Urgent Field Safety Notice
Programmer Software Update
Supporting the Micra™ Transcatheter Pacing System

Model
2090 CareLink™ Programmer 29901 Encore™ Programmer CareLink Network Application Software 2491

January 2019

Medtronic reference: FA856

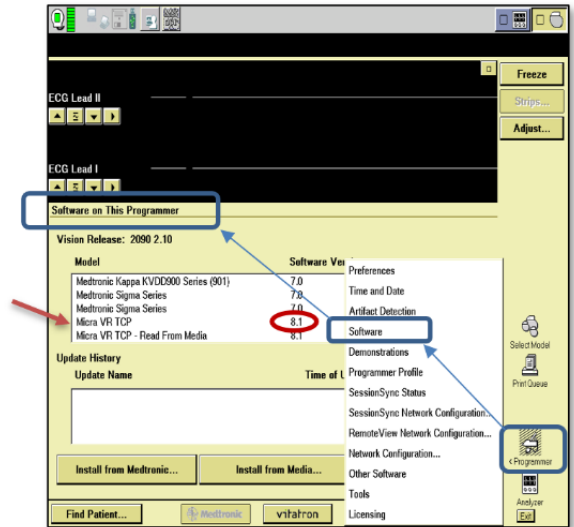
Image 1

Correct software: Micra VR TCP version 8.1 (or higher)

- Select Software (see image 1)
- Scroll through the list of available Software Models in the top selection box until you locate the Micra selection
- Verify the Software Micra VR TCP Version is 8.1

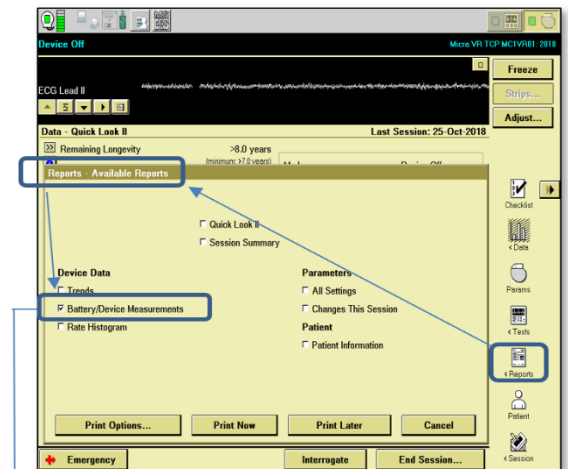
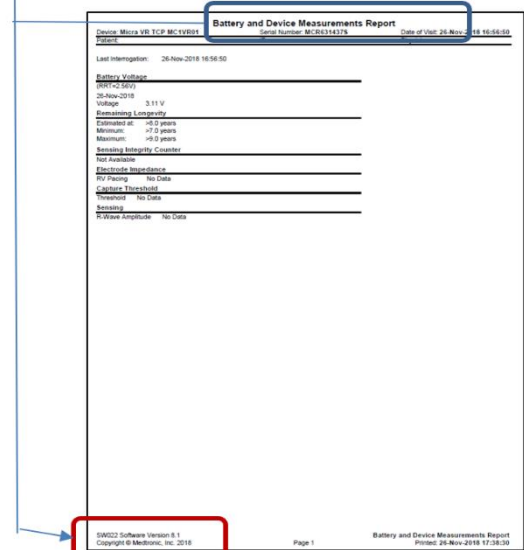
Images 2a and 2b

Any CareLink transmission completed after January 17, 2019 will report the updated remaining longevity estimate. For in-clinic patients who have been interrogated via a programmer, the clinician can view the Battery and Device Measurements Report (Images 2a and 2b) and verify that the Software Application Model ID located in the lower-left corner of the report indicates "SW022 Software Version 8.1".

- Select Reports (see image 2a)
- Select Battery/Device Measurements
- Click Print Now
- Verify the software version printed on the lower left-hand corner is "SW022 Software Version 8.1"
