## Urgent Field Safety Notice

### Single Chamber Temporary External Pacemaker 53401

June 2018

Medtronic reference: FA824

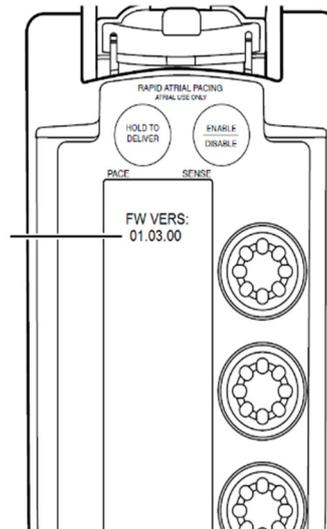
**FIGURE 1- updated firmware displayed in this image**

During power up process, Firmware Version will be displayed for 2 seconds

1. Verify whether 53401 EPGs in your possession are affected
2. If your EPG is affected, complete the following:
  - Determine if the EPG firmware has been updated.
    - Power unit on and view firmware version (Figure 1 below).
    - If firmware version is 01.03.00 or greater, EPG firmware has been updated with correction for this issue. No other action is recommended.
    - If firmware version is 01.02.00, EPG firmware has not been updated. You may arrange to have your Medtronic Service Center update the EPG firmware at no charge.
