URGENT Field Safety Notice

Trilogy Evo and Trilogy Evo O2

23-Jul-2021

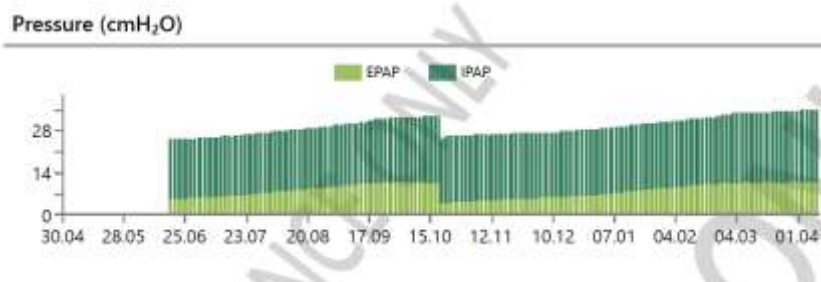
- i. The Respiratory clinician or Physician can detect the increase/decrease in pressure by observing the pressure Trend report in Care Orchestrator/Care Orchestrator Essence as shown below.

If a pressure drift is detected, the decision to reset the device and return to its original, intended settings MUST be made in consultation with a clinician. Take steps to support the patient during a brief interruption in therapy, as needed.

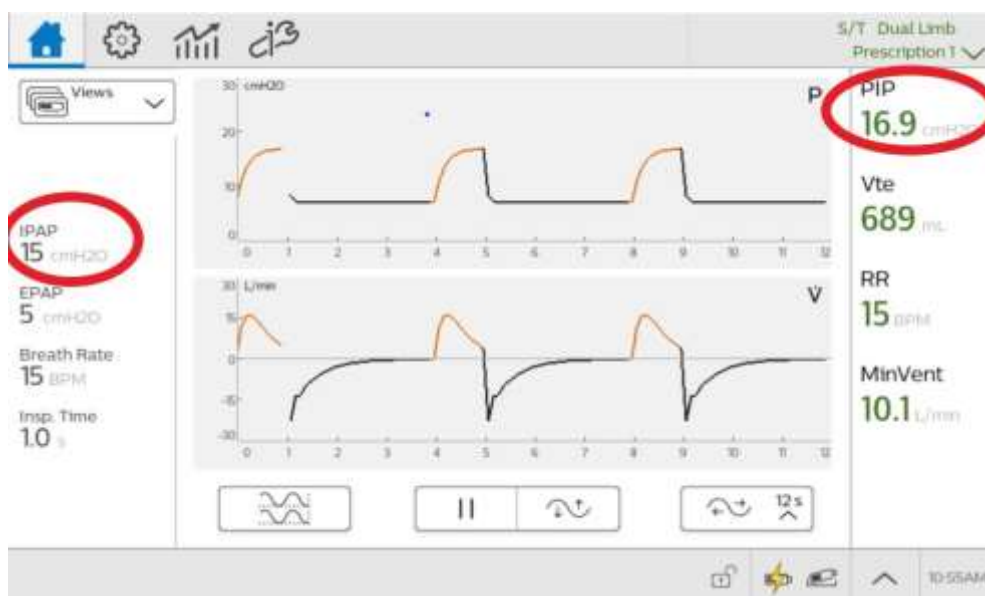
- ii. The caregiver can detect the increase in pressure by observing the measured parameters on the device's screen (measured PIP value or pressure waveform as shown below where the IPAP is set to 15 cmH₂O but because of the pressure increase the actual delivered pressure is 16.9 cmH₂O).
