**URGENT Field Safety Notice**

Trilogy EV300 and Trilogy Evo O2

23-Jul-2021

**Reference: Trilogy EV300 and Trilogy Evo O2 (2021-07-A)**

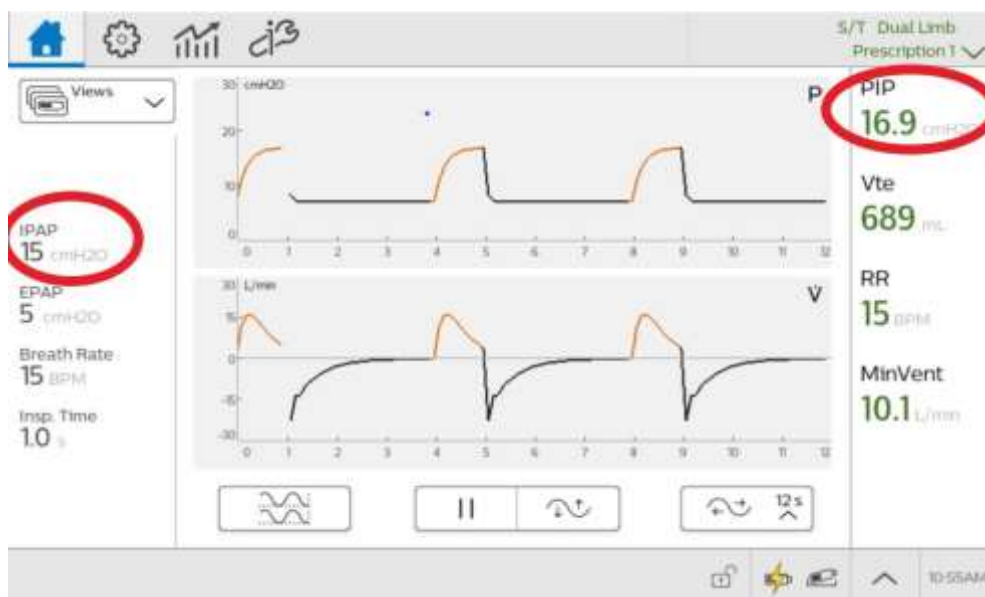
When a Trilogy EV300 or Trilogy Evo O2 model is used continuously without any interruption of therapy over weeks to months, the baseline pressure (that is, the pressure initially set for the patient) may increase or decrease at a rate of up to approximately 2 cmH<sub>2</sub>O per month. This increase applies to the PEEP and the inspiratory pressure at the same rate. The maximum pressure deviation that could be seen is a 10 cmH<sub>2</sub>O shift from the baseline pressure. The pressure regulation alarms will not annunciate with this issue.

The User Interface (display screen) displays the actual pressure that the patient is receiving, which will differ from the baseline setting when this condition occurs.

The caregiver/clinician can detect the increase in pressure by observing the measured parameters on the device's screen (measured PIP value or pressure waveform as shown below where the IPAP is set to 15 cmH<sub>2</sub>O but because of the pressure increase the actual delivered pressure is 16.9 cmH<sub>2</sub>O).

**If a pressure drift is detected, the decision to reset the device and return to its original, intended settings MUST be made in consultation with a clinician. Take steps to support the patient during a brief interruption in therapy, as needed.**

**Philips recommends that users periodically (monthly) perform the steps above to prevent the pressure from drifting.**
