URGENT - Field Safety Notice

Philips EPIQ Ultrasound Systems
Control Panel Arm Swivel Locking Failure

28-JUL-2021

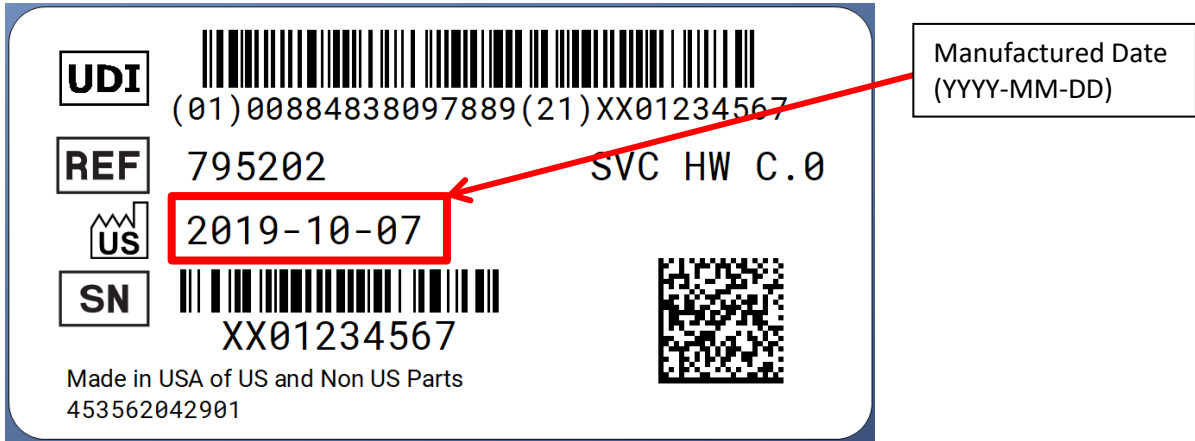
System	Model	Manufactured
EPIQ	EPIQ Elite EPIQ 5G EPIQ 5C EPIQ 5W EPIQ 7G EPIQ 7C EPIQ 7W EPIQ CVx EPIQ CVxi	Between 2020-02-27 to 2021-05-25 (Refer to the main system label shown below for the manufactured date)
