Urgent Field Action Notice for Instrument ASP6025

ASP6025 Tissue Processor

Serial Numbers: 163, 169, 200-821, 823-895, 897-899, 901-1123 (all odd - serial numbers)

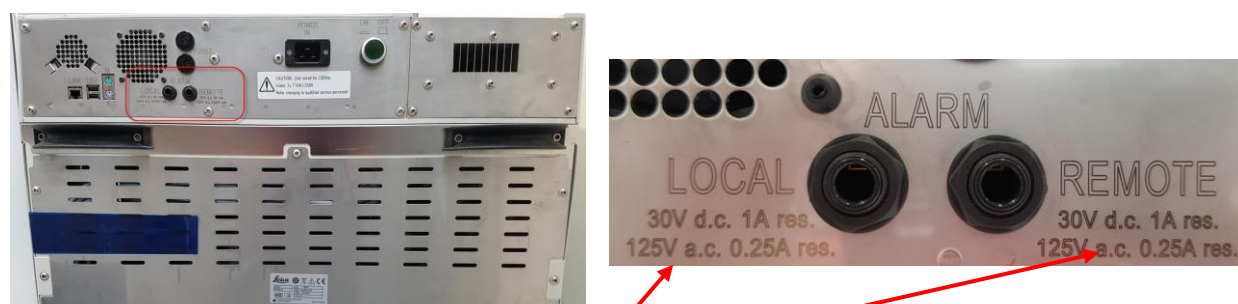
Alarm Connectors labelling

The affected devices mentioned above have incorrect labelling with regard to the specified voltage for the Alarm Connectors on the rear side of the instrument (please refer to the pictures below).

The current incorrect labels specify 125V a.c. as maximum voltage. It has been identified, that if somebody connects such 125V a.c. to the 6.3mm stereo jack, there would be hazardous voltage accessible on the plug which could lead in the worst case to a serious electrical incident.

As an immediate action, we ask that you to first clean the surface around the Alarm Connectors (grease free). Then remove the provided adhesive label (1) from the foil and place it at the Alarm Connectors as shown in the pictures below. The engraved specification must not be readable anymore!

As outlined on the new label, the maximum voltage that can be applied to the Alarm Connector is 30V DC/AC. In case you do not use the External Alarms no further immediate action is necessary. For ASP 6025 Tissue Processors where the external Alarm is used, please ensure that the maximum voltage is not exceeded by the connected external device.

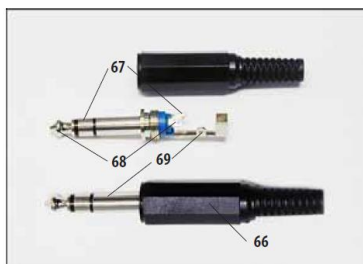
Fig. 63

In addition, the current specification in the Instruction for Use (IFU) has an incorrect labelling with regard to the specified voltage for the Alarm Connectors (please refer to the pictures below).

Each alarm is connected to the plug (66) as follows (Fig. 63):
