INGENIO™ Family DR EL Pacemakers and CRT-Ps (92705305-FA) And Hydrogen Induced Accelerated Battery Depletion (92289212-FA)

Subject: Field Safety Notice – High Battery Impedance May Initiate Safety Mode in INGENIO™, VITALIO™, and ADVANTIO™ pacemakers and INLIVEN™, INTUA™, and INVIVE™ cardiac resynchronization therapy pacemakers (CRT-Ps) (Boston Scientific Field Action Reference: 92705305-FA).

Subject: Field Safety Notice – Hydrogen-Induced Accelerated Battery Depletion in ACCOLADE™, PROPONENT™, ESSENTIO™, and ALTRUA™ 2 pacemakers and VISIONIST™ and VALITUDE™ cardiac resynchronization therapy pacemakers (CRT-Ps) originally communicated in September 2018 (Boston Scientific Field Action Reference: 92289212-FA).¹

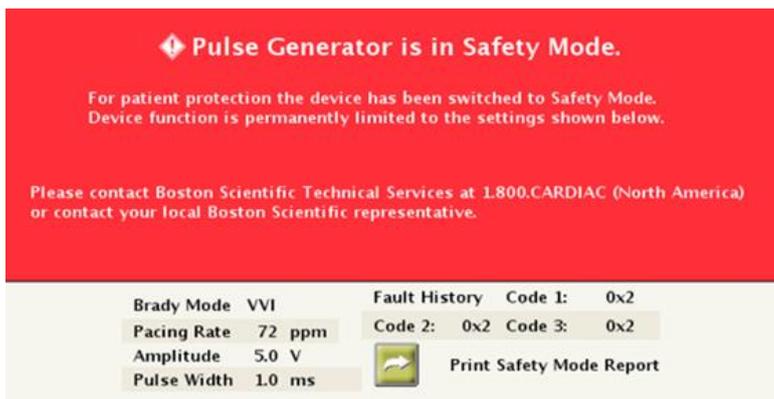
Figure 1. Programmer Warning Screen for Safety Mode

Boston Scientific transvenous pulse generators contain dedicated hardware to support overall safety architecture. In pacemakers and CRT-Ps, this hardware is intended to provide back-up pacing if certain non-recoverable or repeat fault conditions occur. Safety Mode is not intended to be a substitute for chronic pacing therapy. There is a high degree of detectability when a device is operating in Safety Mode. A warning screen is displayed on the programmer upon device interrogation (Figure 1). For those devices monitored via LATITUDE, a red alert will also be issued, indicating the device has entered Safety Mode. If a device is unmonitored for a period of 14 days, it will show up on the 'not monitored' status page on LATITUDE. Whenever a device enters Safety Mode operation, users are instructed to contact Boston Scientific, and Technical Services will advise device replacement.

2- Replacement. If a device enters Safety Mode, schedule replacement. Boston Scientific does not recommend general prophylactic replacement for affected devices. However, for individual patients, factors such as those listed above and shared decision-making may support consideration of early device replacement to mitigate unintended clinical impact(s) due to potential entry into Safety Mode prior to the Explant indicator. In these cases, the following guidance should be considered:
