Urgent: Field Safety Notice Update to October 2016 Field Action: Important information regarding the Medtronic Model 37751 Recharger (Included in Kit Models 37754, 97754, and 37651)

February 2019

Medtronic reference: FA735 Phase II

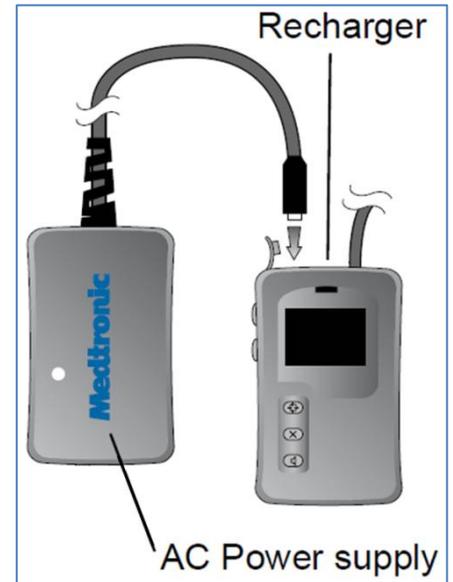
- For product manufactured prior to the design change (Serial numbers starting with "4" [e.g. "NKA4" or "NKU4"]):
 - To prevent this unresponsive error state, the Recharger should be plugged into the AC power supply (by aligning white triangles) prior to starting a recharging session of the neurostimulator and remain connected to the AC power supply until the recharging session has finished (see Figure 1). Note: The AC power supply does not need to be plugged into a power outlet if the Recharger is charged.

- If the Recharger is not connected to the AC power supply during a recharging session of the neurostimulator, the unresponsive error state may occur. Note: This issue can recur after reset if the recharging instructions are not completely followed.

- For product manufactured after the design change (Serial numbers starting with "5" [e.g. "NKA5" or "NKU5"]):
 - Follow the instructions included with the Charging System user manual shipped with the device. Instructions in the user manual do not require the Recharger to be plugged into the AC power supply for a recharging session to occur.
