Urgent Field Safety Notice

Safety Advisory Notice SY015/19/S

Subject: *syngo.CT* Cardiac Function / Planning – Risk of wrong measurement in the annulus-plane

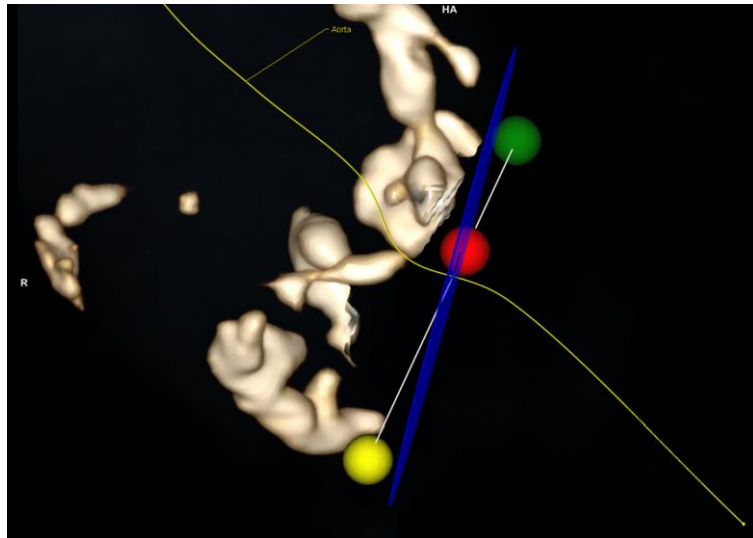
During the automatic procedure a smoothing algorithm subsequently adjusts the shape of the centerline. In unfavorable conditions this smoothing algorithm can result in a slight distortion of the centerline and ultimately in a tilting of the measurement plane compared to the previously defined annulus plane. Any measurements of annular parameters taken under the described conditions might be incorrect due to the tilted measurement plane.

When evaluating the annular dimensions the operator has to ensure that the measurement plane is optimally aligned with the annulus plane. This can be checked in the VRT segment as shown in Fig. 1. For this check, the operator has to move to the annulus plane by pressing the button "Annulus Plane". By activating the vessel diameter measurement tool a blue measurement plane will be displayed and can be compared with the white annulus plane. If they are not aligned, as seen in Fig. 1, any measurements using the cross-sections of the curved planar reformation may not be accurate.

Fig. 1: VRT segment with angular misaligned measurement-plane (blue) and annulus-plane (white) in a worst case situation

Important: If the operator recognizes a significant deviation of two planes as shown in Fig. 1, it is absolutely essential to avoid any measurements in the CPR segments using the cross-sections at the annulus plane.

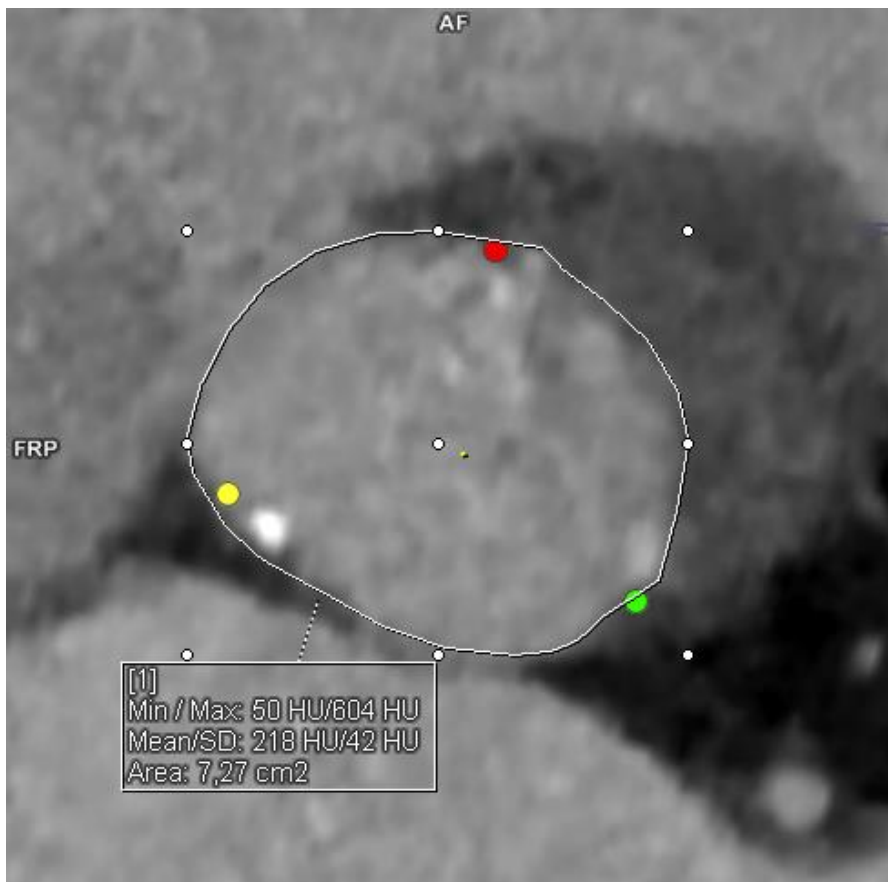
Fig. 2: MPR example for correct manual measurement using the function "ROI Polygonal Measurement"

Workaround: As shown in Fig. 2 any annular measurement shall be performed manually in the MPR segment showing the annulus plane instead. The ROI Polygonal and/or Distance Line tools can be used.
