Urgent Field Safety Notice

O-arm™ 1000 Imaging System

May 2019

Medtronic reference: FA870

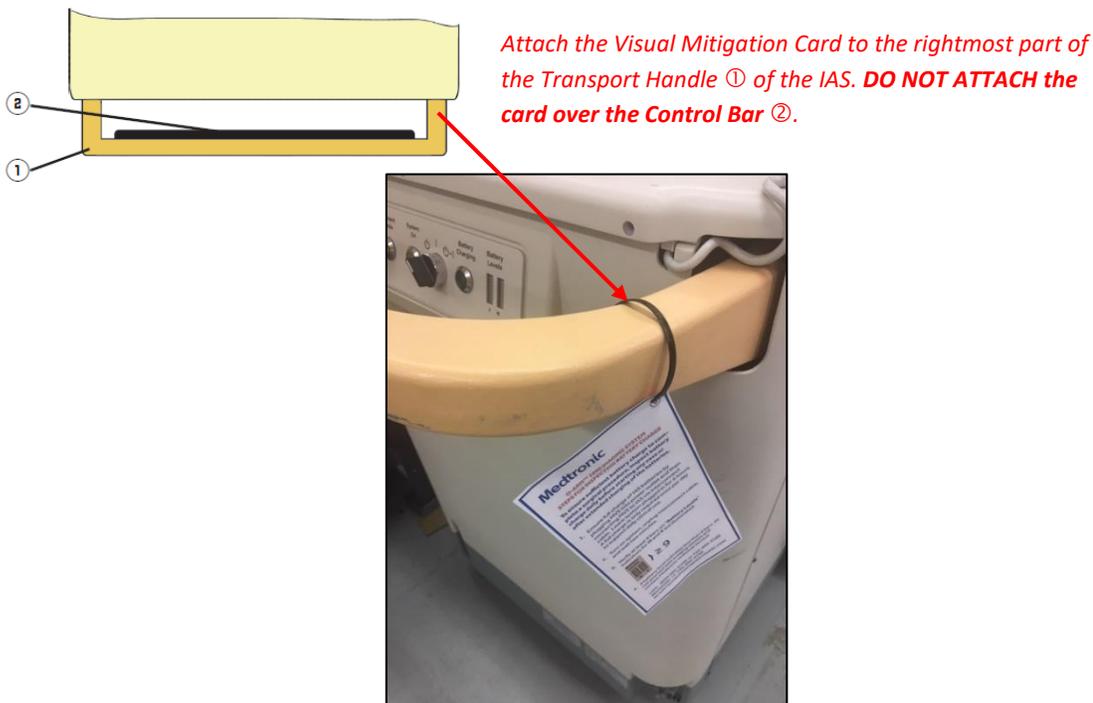
- 1) Attach the Visual Mitigation Card to the IAS of your O-arm™ 1000 Imaging System, as illustrated in the image below, and follow the directions as noted.

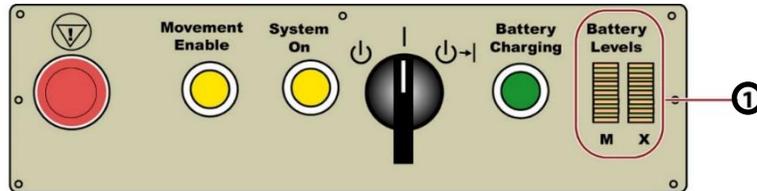
FIGURE 1

Battery Level Indicators: On the IAS Power Control Panel shown in Figure 1, the two columns of yellow LED lights (①) indicate the battery levels for the motion batteries (M) and the X-ray batteries (X). See “Battery Charge Level Indicators” in the user manual for more information about battery charge levels represented by the scrolling LEDs. See “User Performance Checks” in the user manual to ensure proper operation of the machine.

- While the Image Acquisition System (IAS) is turned on, unplug the interconnect cable and wait two minutes.
- Check the battery charge indicators on the power control panel.
- Verify that the **X** and **M** battery level indicators have at least 9 out of 10 bars illuminated to ensure sufficient battery charge to accomplish the procedure.
- If battery level indicates less than 9 bars, do not proceed with imaging session and contact Medtronic technical service +1-720-890-3160; or via email to RS.NAVTECHSUPPORT@MEDTRONIC.COM.

- While the Image Acquisition System (IAS) is turned on, unplug the interconnect cable and wait two minutes.
- Check the battery charge indicators on the power control panel.
- Verify that the **X** and **M** battery level indicators have at least 9 out of 10 bars illuminated to ensure that the battery chargers and batteries are recharging properly.
- If battery level indicates less than 9 bars, do not proceed with imaging session and contact Medtronic technical service +1-720-890-3160; or via email to RS.NAVTECHSUPPORT@MEDTRONIC.COM.
