Urgent Field Safety Notice **Software Distribution Network & Associated Programmers**

Product Name	Model Number
CareLink™ 2090 Programmer	2090; All Serial Numbers
CareLink Encore™ 29901 Programmer	29901; All Serial Numbers

FA844

October 2018

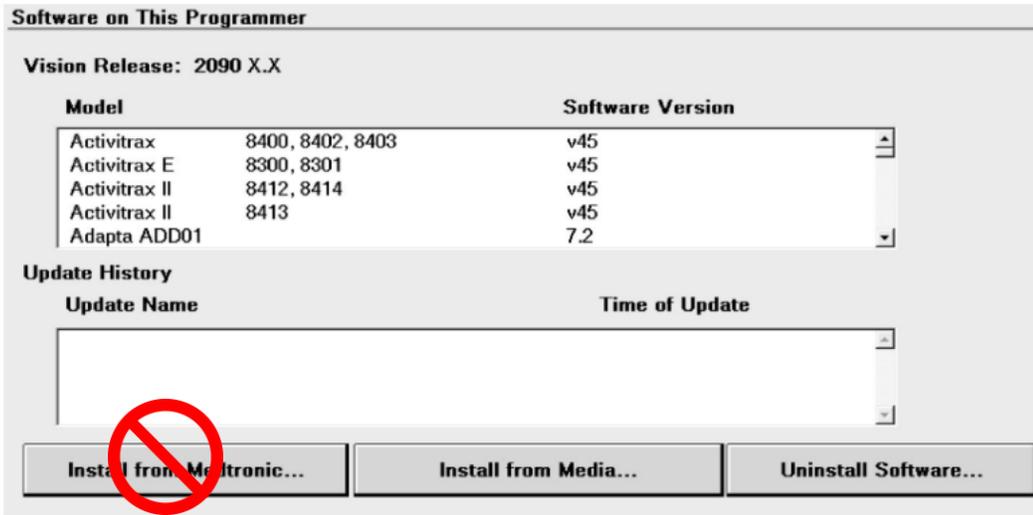
Appendix A Programmer Software Screen

Do not attempt to update the programmer via the SDN. If you select the "Install from Medtronic" button, it will result in an unsuccessful installation of software because access to the external SDN is no longer available.

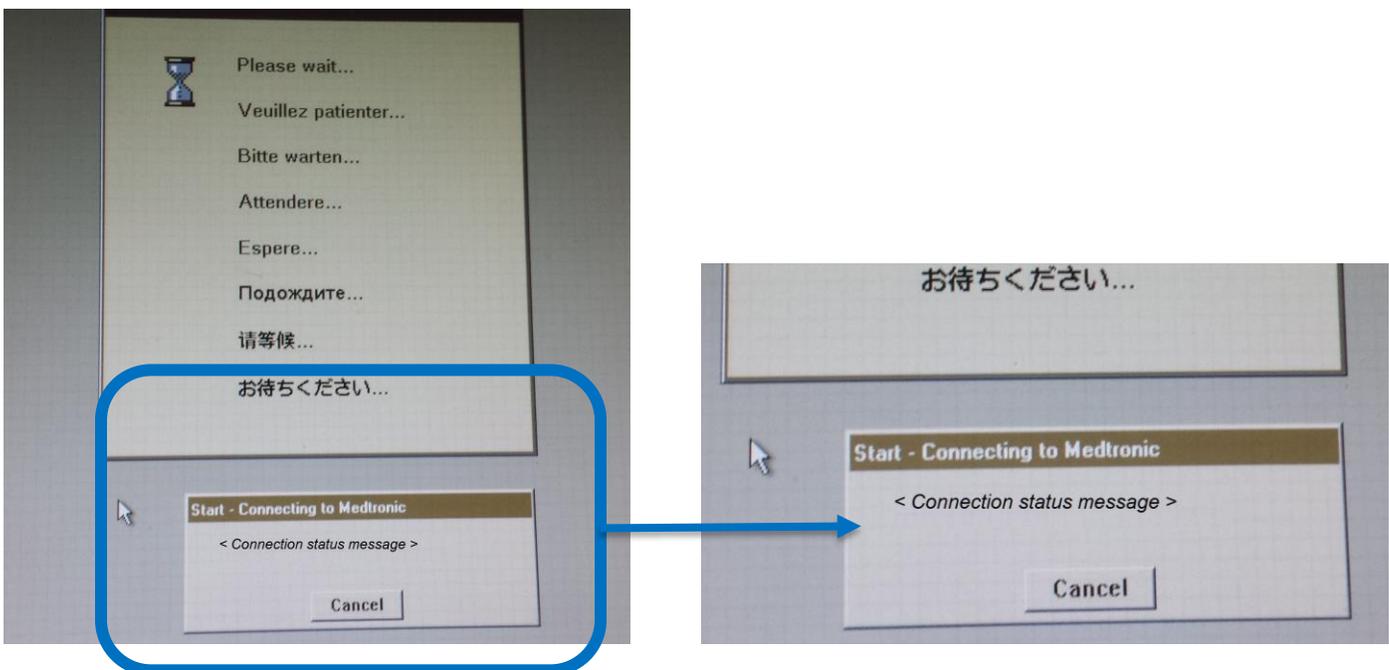
Several messages may be observed if installation of software from the SDN is attempted (e.g. "Install from Medtronic..."). See images below for example as to what will appear on the programmer display during the installation attempt. Below the larger "Please Wait" message will be a smaller window with a <connection status message> displayed; refer to highlighted area below. The connection status messages may alternate *between* "Connecting...", "Searching for Network...", "Logging in...", "Unable to connect to local network", and "Unable to connect to Medtronic". Since the SDN is no longer available, **the user should select "Cancel" to terminate the installation attempt.**

If the user cycles power on the programmer without first cancelling the installation attempt, upon power-up a count-down window will appear on the screen for approximately 30 seconds with "Yes" and "No" buttons. The user should select "No" to terminate the installation attempt and return to the Model Select screen. If the user selects "Yes" or does not respond prior to the 30-second time out, the programmer will attempt the installation again, and the process described above will repeat until the user either selects "Cancel" or selects "No" during the count-down window.
