Update to Medical Device Correction
Philips M1783A/M5526A Sync Cables & 989803195641 ECG Out Cables
Electrical Interference Could Pose a Risk to Patients

URGENT - Medical Device Correction
Philips M1783A/M5526A Sync Cables & 989803195641 ECG Out Cables
Electrical Interference Could Pose a Risk to Patients

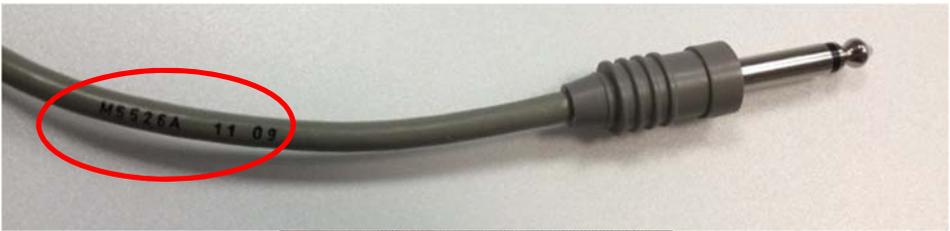
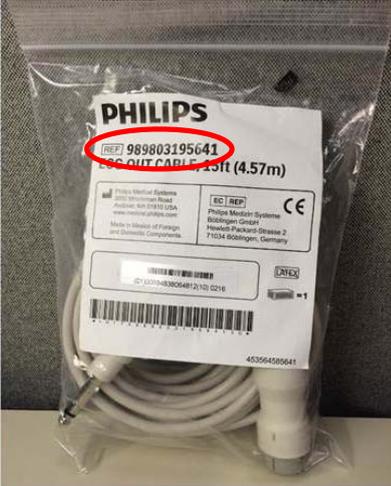
<p>HOW TO IDENTIFY AFFECTED PRODUCTS</p>	<p>Philips M1783A/M5526A sync cables and 989803195641 ECG out cable identified above are affected by this issue.</p> <p>The model numbers are printed on the outside of the cable, near the end with the ¼" phone plug and on the bag label.</p>

<p>ACTION TO BE TAKEN BY CUSTOMER / USER</p>	<p>Customers should remove affected sync cables and ECG out cables from service and destroy them, documenting such action on the attached reply form, which should be returned to Philips. Customers should retain a copy of the reply form.</p> <p>The customer should follow the Instructions for Use that describe the recommended approach for performing cardioversion with the XL+ and MRx monitor/defibrillators. The ECG trunk cable can be disconnected from the Philips bedside monitor and connected to the monitor/defibrillator before delivering therapy; this is the preferred source of an ECG waveform for synchronization.</p>
