Field Safety Notice

Tissue-Tek® AutoSection®, Item# 5000, up to serial number 0297

Safety communication by EUROPEAN REPRESENTATIVE

Date: June 29, 2018

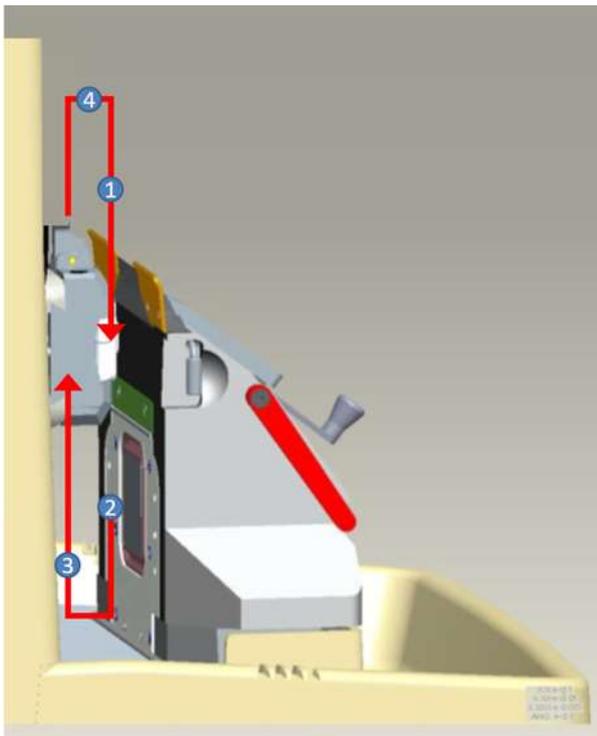
ALIGNMENT STEPS

- 1) Placement of block and initialising alignment
- 2) Alignment of block
- 3) Bringing the chuck back up
- 4) Start face/section after alignment

Only during the first three steps of the alignment the issue will occur when the emergency button is pressed. The chuck will return to its upper position to reinitiate and will start without further notice after a few seconds.

Since the user will not anticipate the chuck to move at this stage, it is possible that the user is near the chuck (and therefore the blade) when the motion starts again. This poses a risk to user health.

Software version 5.90a which is expected to be released within 2 weeks, will be a mandatory upgrade in which this software bug is solved.

An instructed customer can still use the AutoSection in their daily routine while being alert that after an emergency stop within the before mentioned conditions the chuck will start moving again. This movement could simply be stopped by pressing the touchscreen like how one would normally stop the movement of the AutoSection.
