URGENT: FIELD SAFETY NOTICE (Correction)

Specific product codes and lots of Protexis Latex Micro Surgical Gloves

Event-2020-03257

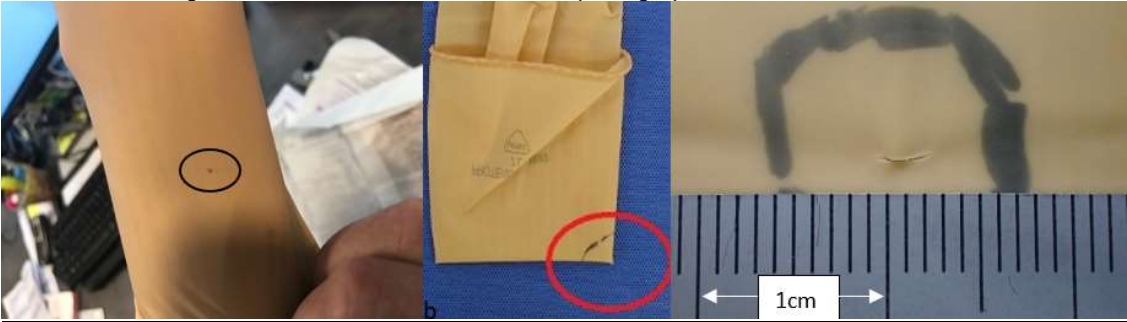
Previously, in **July/August** 2020, Cardinal Health initiated a voluntary recall (Event-2020-03063) of specific production lots of Cardinal Health™ PROTEXIS™ Latex Micro Surgical Gloves that were distributed between June 2019 and July 2020. The investigation into this event determined the potential root cause to be a change to the latex maturation time, which was resolved.

<p>Description of the problem:</p>	<p><u>What is the issue?</u> Cardinal Health™ PROTEXIS™ Latex Micro Surgical Gloves may have possible holes and donning tears at the folding area around the cuffs. Please see photographs below.</p>

<p><u>What other actions is Cardinal Health taking?</u> Cardinal Health is investigating the root cause of this issue. Corrective actions will be implemented and monitored to ensure that the issue has been corrected.</p>
<p>Actions requested on your part:</p>	<ol style="list-style-type: none"> 1. INSPECT your inventory for affected product (see attachment 2 for item code and lot location). Retain a copy of this notice with the product. 2. COMMUNICATE with all personnel that utilize the product of the risk of possible holes and donning tears at the folding area around the cuffs. 3. INSPECT the entire surgical glove for any holes or tears after donning has occurred. <ol style="list-style-type: none"> a. If a hole or tear is detected, the glove must be discarded and a new glove must be obtained. Inspect the new glove for holes or tears in the same manner. b. Double-gloving is recommended to provide additional barrier protection. 4. NOTIFY any customers to whom you may have distributed or forwarded affected product about this product correction notice. 5. RETURN the enclosed acknowledgment form 6. MAINTAIN awareness of this notice until all affected product has been utilized.
