**URGENT FIELD SAFETY NOTICE
UPDATED**

2021-PD-US-005 RevB

Philips EPIQ & Affiniti Ultrasound Systems
System Lock-Up Issue and PW Doppler
Signal Dual Mode Issue

OCT - 2021

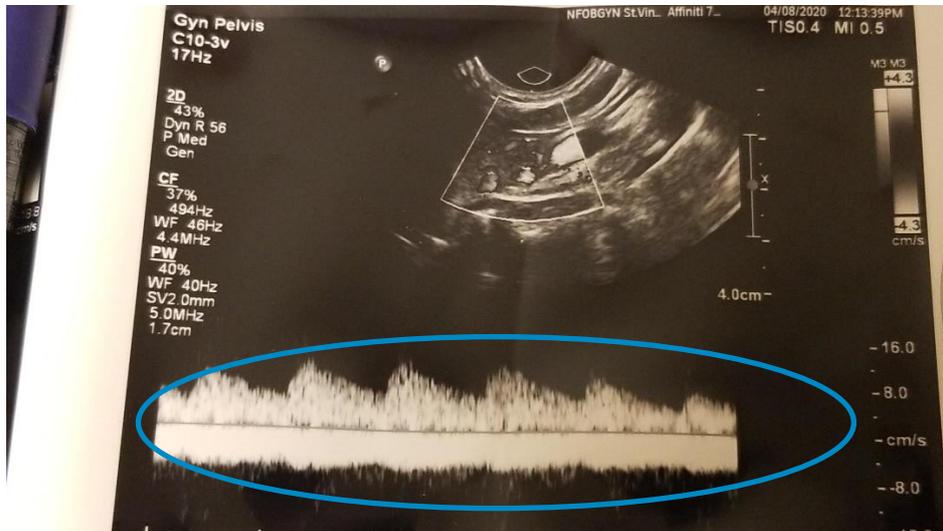
Figure 1 shows a normal PW Doppler signal, highlighted in the blue oval. When the issue occurs, this signal is compromised as shown in Figure 2 below, highlighted by the red oval.

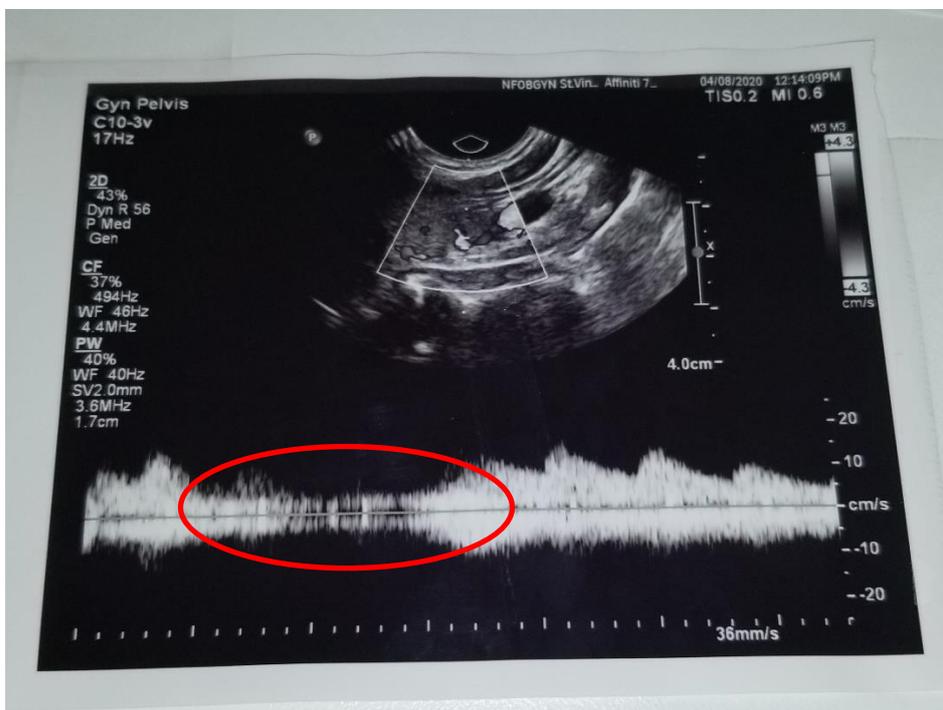
Figure 2

Philips Ultrasound has identified an issue where the Pulse Wave (PW) Doppler signal, both visual and audio can be compromised under specific workflows.

The issue occurs if a user enters Dual Mode, exits Dual Mode and then turns on the PW Doppler signal. The PW Doppler signal cannot be engaged while in Dual Mode, so the user must leave this Mode to use PW Doppler. At this point, having been in Dual Mode creates the issue in the PW Doppler Signal.

The PW Doppler function can be used prior to entering Dual Mode. This avoids the issue by **preventing** the Dual Mode from impacting the use of the PW Doppler function.

- 1) The user can reselect the transducer after exiting Dual Mode which will resolve the issue in the signal allowing normal use of the PW Doppler function. Note, this mitigation would need to be used each time the user goes into and exits Dual Mode. Note, any function which reselects the transducer, such as closing and opening the exam will also solve the problem.
- 2) The user can validate their PW Doppler signal using a different Doppler Mode such as Color Doppler. Color Doppler is not affected by this issue. Note, Color Doppler is a different clinical function. However, its output correlates to the PW Doppler output to indicate to the user there is a problem.

A Philips Field Service Engineer or Representative will contact you to schedule a software update for all ultrasound systems that have VMQ5.0., 5.0.1 or 5.0.2 software to permanently resolve these issues (reference FCO79500535).
