Harvest Healthcare Ltd

Important Field Safety Notice

Date 25.01.18

HA200 Unipump - Fitted to the following systems: Opal & Salisbury overlay mattresses. Chatsworth, Opal Plus, Prime comfort active replacements mattresses. Seats cushion system HH20. Systems produced in 2016 and 2017 are affected

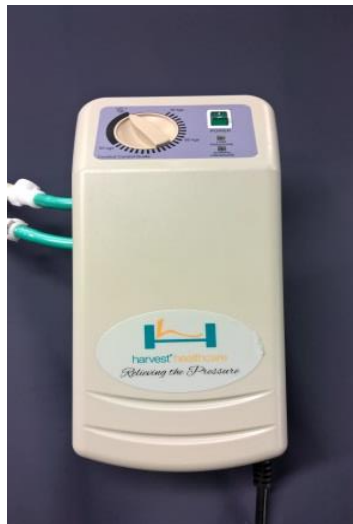
The pressure indicator is designed to indicate if the pump has detected a pressure drop when connected to an active alternating system. An audit has identified a failure on some units which are now in service. If the pressure indicator has stopped working, this will not activate if there is a deflation of the mattress. The Pump has been supplied with overlay systems and replacement systems. A visual inspection of the mattress to see if it has completely deflated is advisable as part of your routine daily checks.

The pump can be clearly identified by looking at the label situated on the underside of the pump. **EZ 16** indicates the year as 2016. These pumps have been supplied as individual units, or as part of active seat cushion and with alternating mattress systems.

It is important to inspect any pump you have regardless of its age to ensure the low pressure indicator is working correctly.
