FIELD CORRECTIVE ACTION NOTICE

Leica M525 F20 Microscope System

FCA Identifier: CAPA-HER-MD-18-001

Enhancement of instructions for use and additional markings to prevent inadvertent tipping

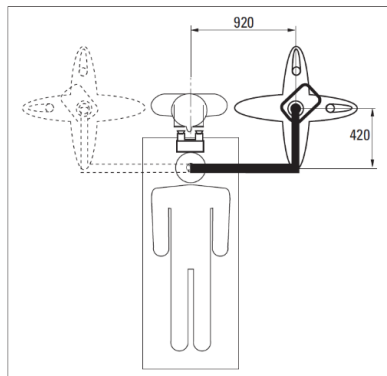
Figure A: Intended positioning- Option 1

The enhanced revision of the Leica M525 F20 instruction for use will describe the intended positions of the Leica M525 F20 in the OR as shown in Figure A and B below.

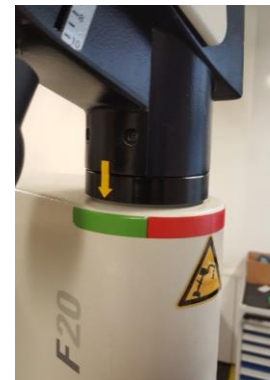
Figure C: Scale Indicator

An additional marking with a scale indicator and arrow as shown above in Figure C will assist Leica M525 F20 users to position the horizontal arm and swing arm with as intended with an angle of approximately 90°:

- The yellow arrow pointing to the green area shows that the device is set up as intended.
- The yellow arrow pointing to the red area shows that the device is not set up as intended and special care is needed to prevent inadvertent tipping when handling the device.

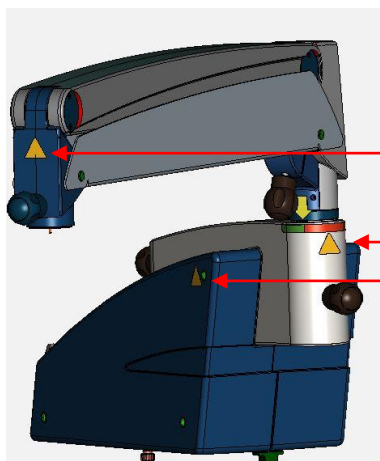
Figure D: Position of new Warning Label

Four additional warning markings (see Figure E) will be placed on the Leica M525 F20 to make users aware of tipping hazards when handling the device as shown below in figure D and F:
