IMPORTANT FIELD SAFETY NOTICE

CentriMag™ Acute Circulatory Support System Motor Model: 201-10002
Compatible with CentriMag™ Pump and PediVas™ Pump

September 5, 2018

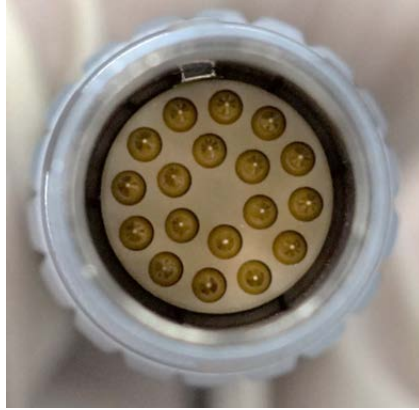
Figure 2: Motor Connector Pin View

- Visual inspection regarding inspection for motor cable damage from the CentriMag Circulatory Support System Operating Manual and supplemental pages (for 1st Generation Consoles)
1. Visually inspect the CentriMag Motor connector for bent or broken pins. Check for burn marks or melted plastic.

Note: If there are any issues while connecting the CentriMag Motor to the CentriMag Console, inspect the Motor port on the rear of the Console for damage, particularly for any broken pins that may be lodged inside.

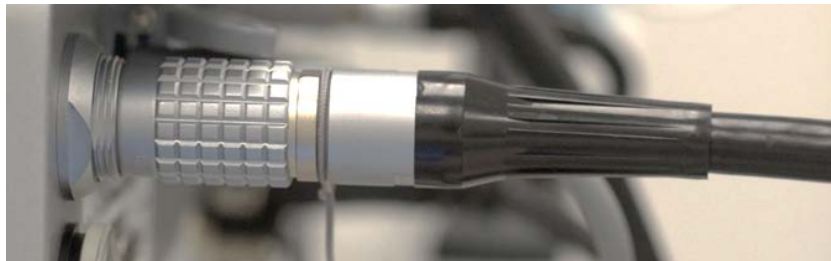
Figure 3: Cable Bend Relief at the Console Connector

2. Visually inspect the entire length of the CentriMag Motor cable, including both bend reliefs (see Figures 3 and 4), for any damage such as separations of the bend reliefs, deformations, kinks, or cuts. These types of damage indicate wear and tear or previous rough handling of the cable, which has the potential to result in internal wire damage. Cable thickness and shape should be uniform throughout the length of the cable.

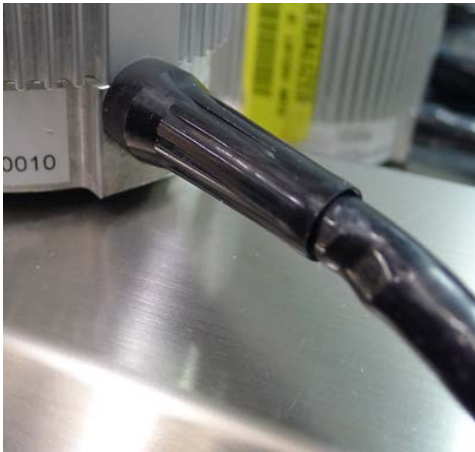
Figure 5: Cable Damage at the Motor Bend Relief

Our analysis of devices associated with the motor stop field complaints showed that the motor stop can be attributed to a break of a wire or short circuit between wires within the electrical cable where the cable exits the motor cable bend protection. This damage may be avoided by ensuring proper handling, such as avoiding tight bending of the cable, or winding the cable around the motor during storage during the life of the motor.

Before each use, verify that the cable connecting the Motor to the Console is not kinked, which can occur with improper handling such as wrapping the cable tightly around the Motor. If the cable is kinked, replace the Motor.
