URGENT Field Safety Notice

Philips **Interventional Hemodynamic Application** R1.2.X, R1.3.0 and R1.3.1
Potential incorrect functional measurement

30-APR-2024

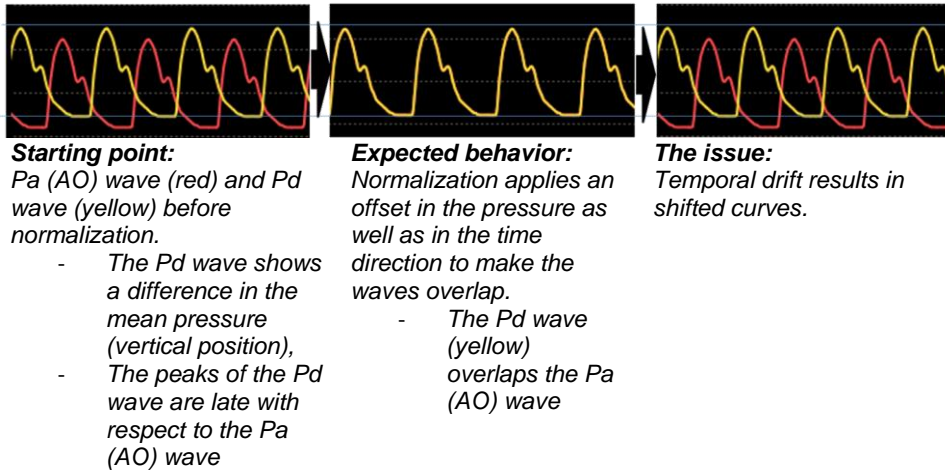
Philips has become aware that this synchronization may not be correct, which causes the wave data from one device to be delayed with respect to the wave data from the other device. This time shift can occur in two different forms, being:

- A delay of the Pd wave with respect to the Pa wave that is increasing over time ('drift'). The drift decreases in time towards zero eventually leading to a constant shift between the Pa wave and Pd wave (see Figure 1 below).

Figure 1 – Pa (AO) wave (red) and Pd wave (yellow) normalization issue

A delay of the Pd wave with respect to the Pa wave can result in incorrect functional measurements, which may lead to misdiagnosis (under or over treatment due to the drift going unnoticed).

Philips will install a software update to correct this issue. A Philips representative will contact you to schedule an onsite visit to perform the upgrade (reference FCO72200542).

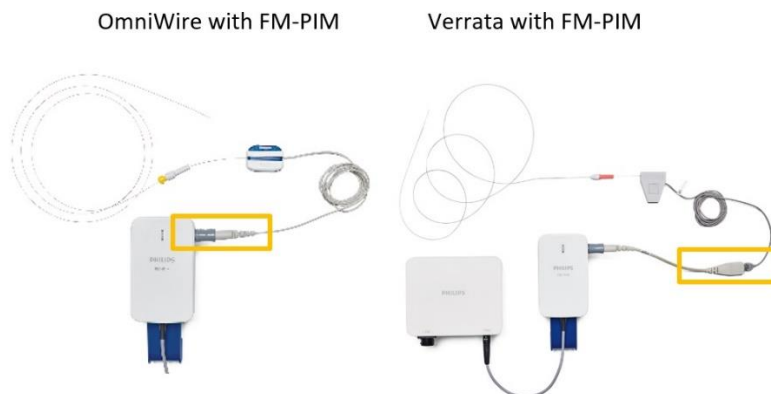
Figure 3 – Connection points of two types of cables (OmniWire and Verrata) to the FM-PIM to be used

- Step 1: Connect the cable of the OmniWire or Verrata wire to the FM-PIM. The Philips Interventional Hemodynamic System will start “auto-zeroing” the pressure wire and the PHA display in the exam room during this process will automatically show the message “Auto-zeroing the FM-PIM pressure wire”.

- Step 2: Disconnect the cable from the FM-PIM and wait for the Philips Interventional Hemodynamic System to show the message “Connect the plug of the FM-PIM” on the display in the exam room.

- Step 3: Reconnect the cable again with the FM-PIM. Use the cable connector indicated with the yellow boxes in the Figure 3 below.

- Step 4: Allow the wire to “auto-zero” again (see Step 1) and continue with the iFR or FFR measurement.
- In case the steps described above are not executed and/or the described issue is observed, perform the normalization procedure in accordance with Section 6.9 of the Instruction for Use
