**URGENT Field Safety Notice**

Wired Avalon Ultrasound Transducer (product number 867246)  
Inaccurate Fetal Heart Rate (FHR) measurements when monitoring multiples

22-MAY-2024

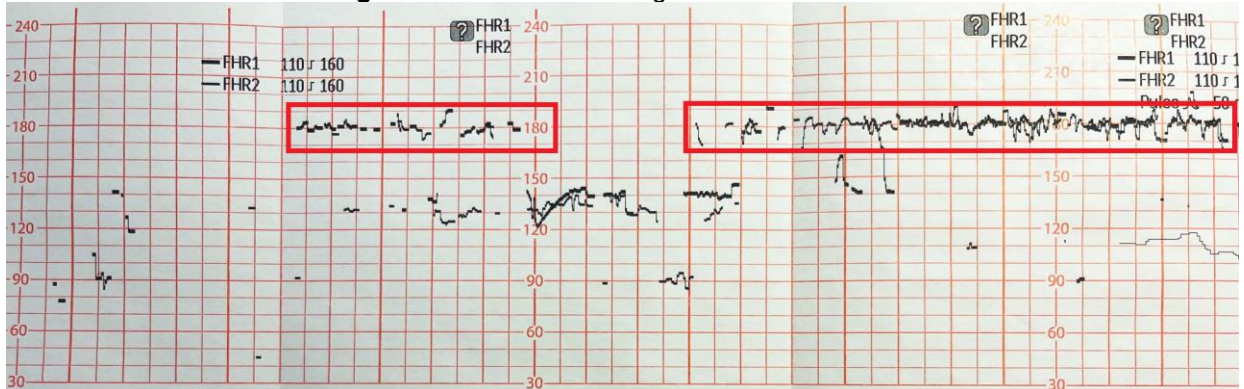
**Figure 1. FHR Trace During Occurrence of Issue**

It was found that the latest version of the wired Avalon Ultrasound Transducers (867246) may report inaccurate Fetal Heart Rate (FHR) measurements when monitoring multiples (twins or triplets): In situations where the physiological signal (echo from the fetal heart) is absent or very weak (e.g. in early weeks of pregnancy), there is a tendency of the wired Ultrasound transducers to interfere with each other and subsequently to produce an artificial FHR, mostly at approximately 180 bpm. The use cases affected by this issue are twin or triplet monitoring with wired Ultrasound Transducers including at least one transducer with software version L.01.04. The population at risk is women with multiple gestation (twins/triplets).

Figure 1 below shows an example trace of FHR measurements when this issue occurs. Highlighted in red are the sections of the trace which show the issue as it would be present for the clinical user.

1. The affected Avalon wired transducer with software revision L.01.04 must not be used when monitoring multiples.
2. The Avalon wired Transducer 867246 can be safely used in the following cases:
  - a. Monitoring the FHR of **singletons** (ca. 97% of all pregnancies) with any wired Avalon Ultrasound Transducers, including 867246 Ultrasound Transducer with software revision L.01.04.
  - b. Monitoring also of twins or triplets with wired Ultrasound Transducers, as long as none of the involved transducers is an 867246 Ultrasound Transducer with software revision L.01.04.

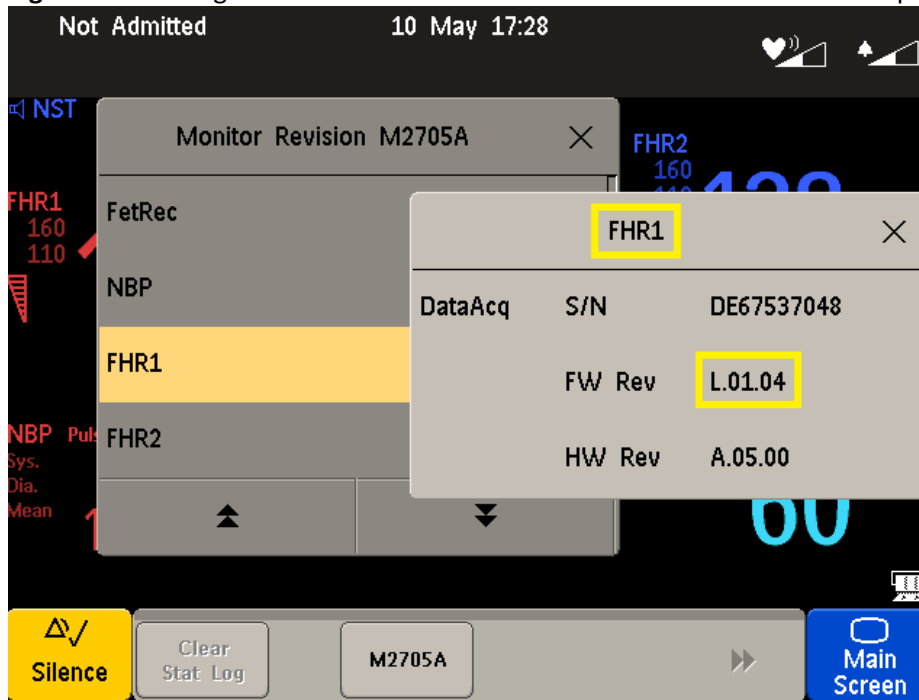
**Figure 2.** Checking the Transducer Software Revisions at the Avalon FM display

1. Enter the Software Revisions screen in the fetal monitor graphical user interface:  
**Main Setup > Revisions > [FHR to check, e.g. FHR1]**

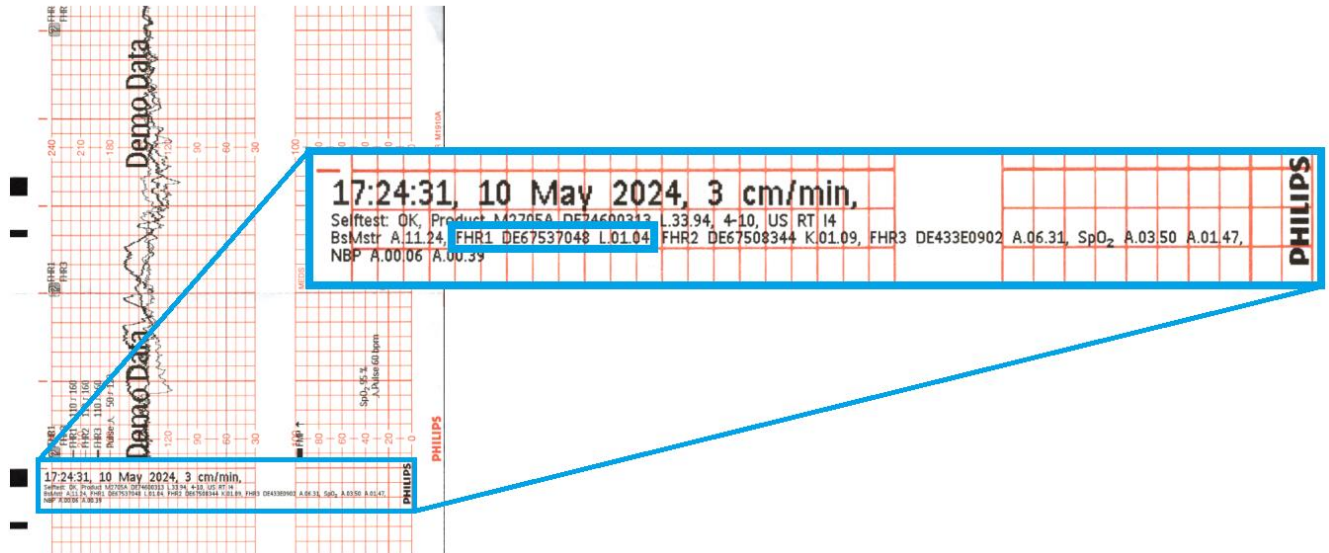
**Figure 3.** Checking the SW revisions of all connected transducers with the recorder header information

2. Review the recorder header of a printed trace
