To all end-users of
 NIHON KOHDEN Bedside Monitors series *Life Scope G9* (CSM-1901)

Rosbach v.d.H., April 2017

Subject: Important FIELD SAFETY NOTICE
**Information about a Field Safety Corrective Action for NIHON KOHDEN
 Bedside Monitors series *Life Scope G9* (CSM-1901, CU-191RK and CU-192RK)
 FSCA Ref. "CSM-1901/2017/1"**

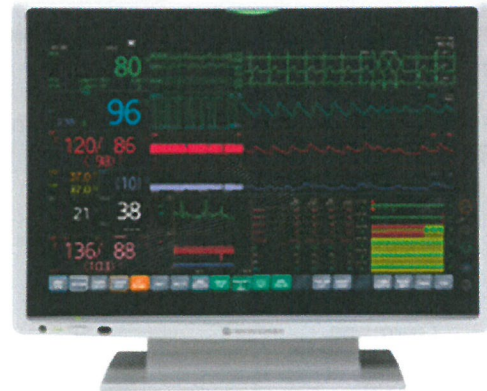
Life Scope G9 (CSM-1901)

The potential affected units can be identified by the model name and serial number which both are located on the product identification label at the backside of the Bedside Monitor *Life Scope G9*.
