URGENT: MEDICAL DEVICE RECALL/EXCHANGE

2nd Generation neoBLUE LED Phototherapy Lights

March 2017

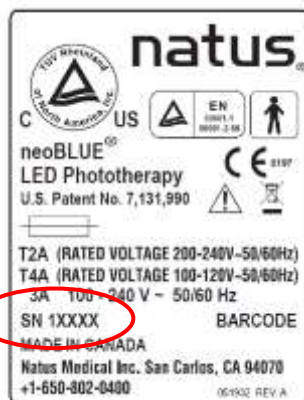
2. **Use the Reply form on the following page to record the Serial Number found on the back panel of the light enclosure(s).** Use as many reply forms as are necessary to record all affected lights.

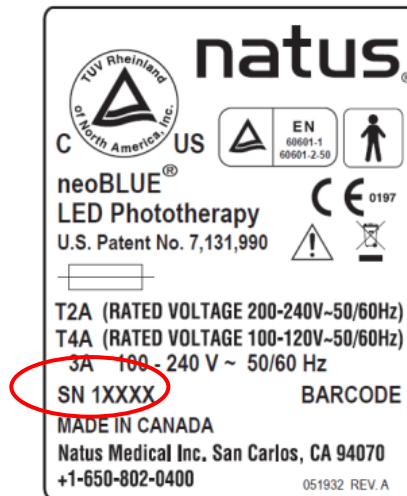
Figure 1 – neoBLUE Serial Number label

1. Photograph the serial number label (see Figure 1) on the back side of the light enclosure. Please ensure that the serial number is legible in the photo. **This photograph is one of the three items required to be returned to Natus for each light disabled.**

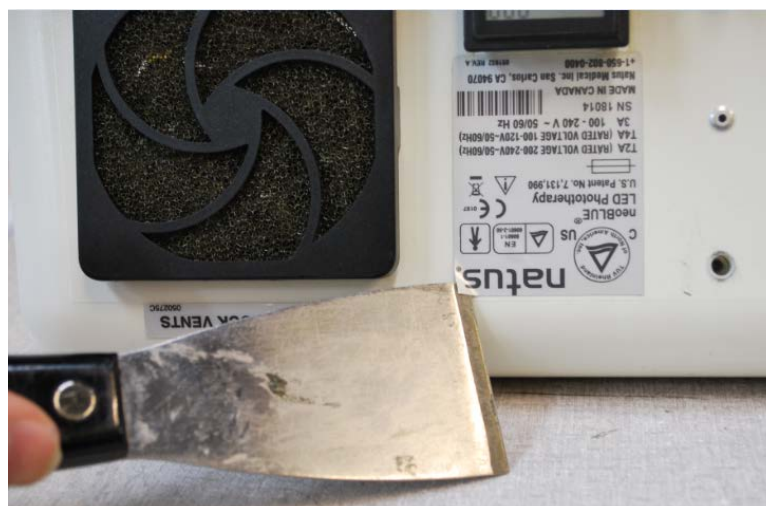
Figure 2 – Use flat-edge knife to lift Serial Number Label

2. Remove the Serial Number Label from the enclosure (see illustrative steps below). **This Serial Number Label is the second of three items required to be returned to Natus for each light disabled.**
 - a. Disconnect the power source from the unit and remove the unit from any mounting mechanism. Place the light enclosure on a work bench with the translucent diffuser facing upwards.
 - b. Use the flat-edge knife to carefully lift an edge of the Serial Number Label, as shown in Figure 2 below.

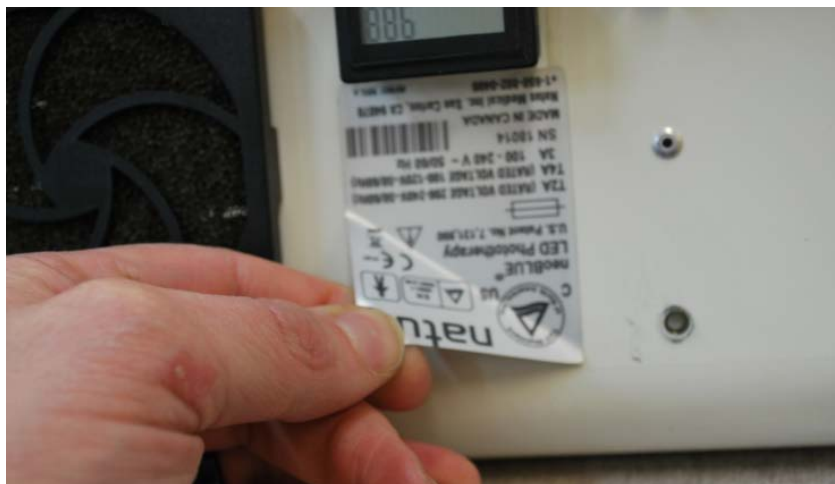
Figure 3 – Peel Serial Number Label from enclosure

- c. Gradually peel the Serial Number Label from the enclosure, as shown in Figure 3 below.

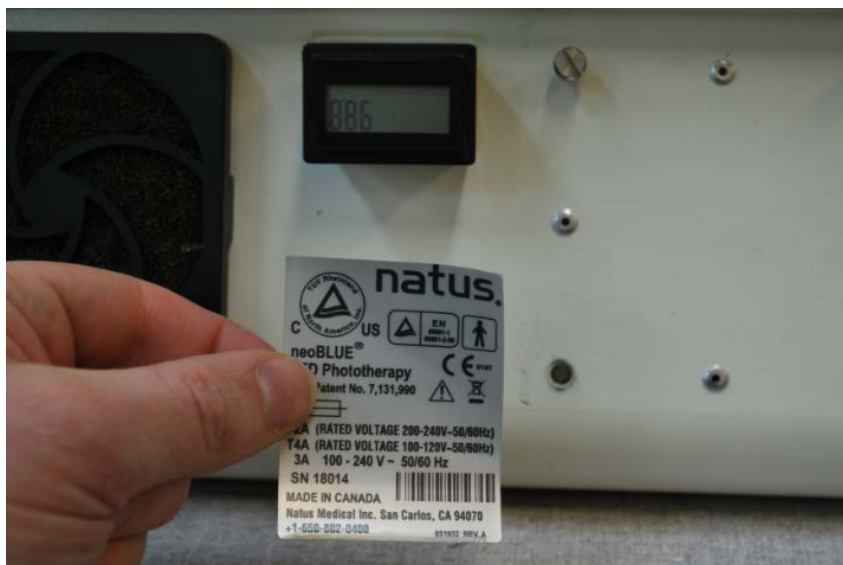
Figure 4 – Remove Serial Number Label from enclosure

- d. Remove the Serial Number Label from the enclosure, as shown in Figure 4 below.

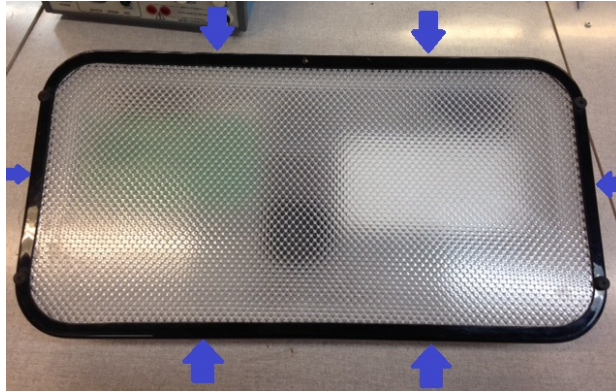
Figure 5 - Unit with diffuser facing upwards.

3. Ensure power source is still disconnected and place unit on a flat surface with the diffuser facing upwards (as shown in Figure 5). Using a Philips screwdriver, remove the six screws securing the diffuser (indicated by arrows in Figure 5) and remove the diffuser from the unit, setting it aside.

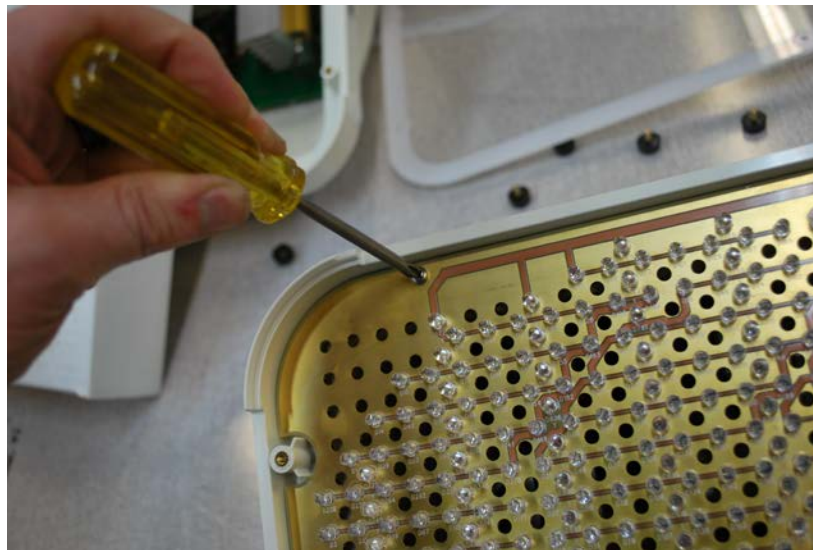
Figure 6 - Unit with enclosure removed and LED PCBA exposed.

4. With the diffuser removed, the LED Printed Circuit Board Assembly (PCBA) is exposed. Referring to Figure 6, remove the screws holding the LED PCBA to the enclosure.

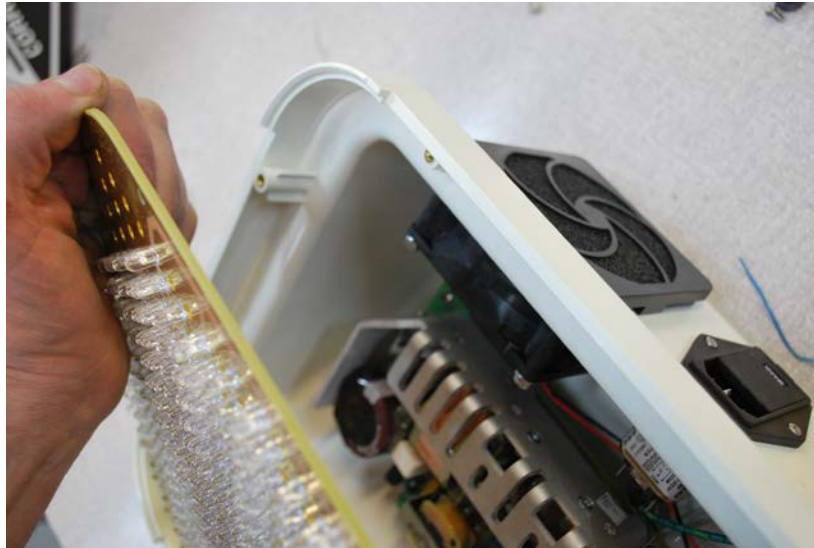
Figure 7 - Lift LED PCBA away from enclosure.

5. After the screws are removed, gently lift the LED PCBA away from the enclosure (Figure 7) and unplug the connector from the back of the LED PCBA (Figure 8).

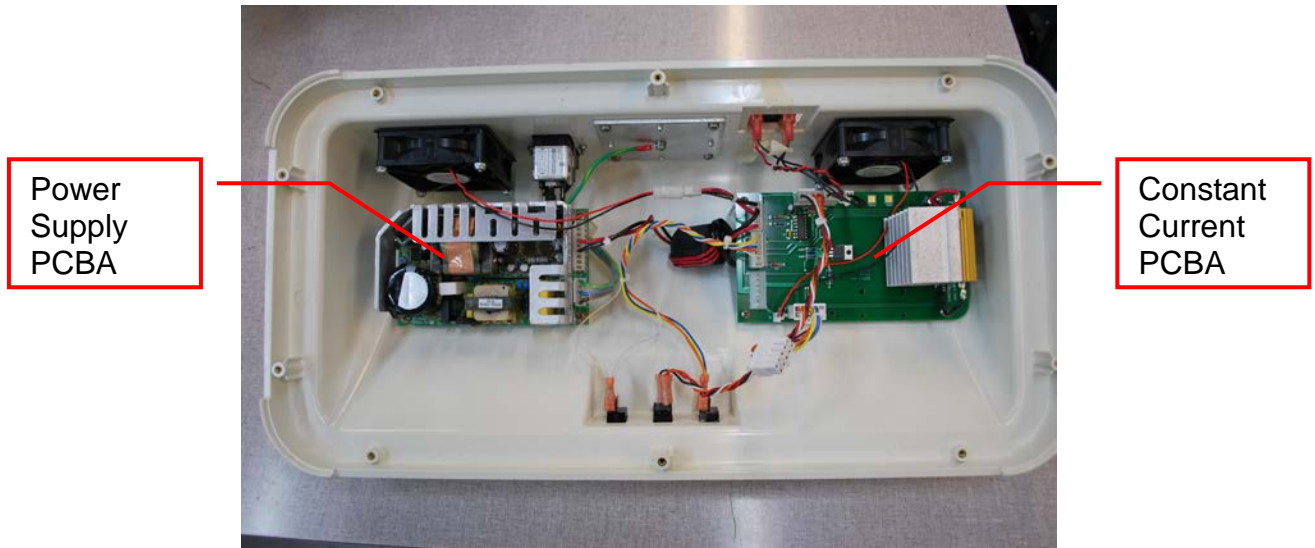
Figure 9 - Unit with diffuser and LED PCBA removed.

The power supply Printed Circuit Board Assembly (PCBA) and constant current PCBA are now exposed. See Figure 9.

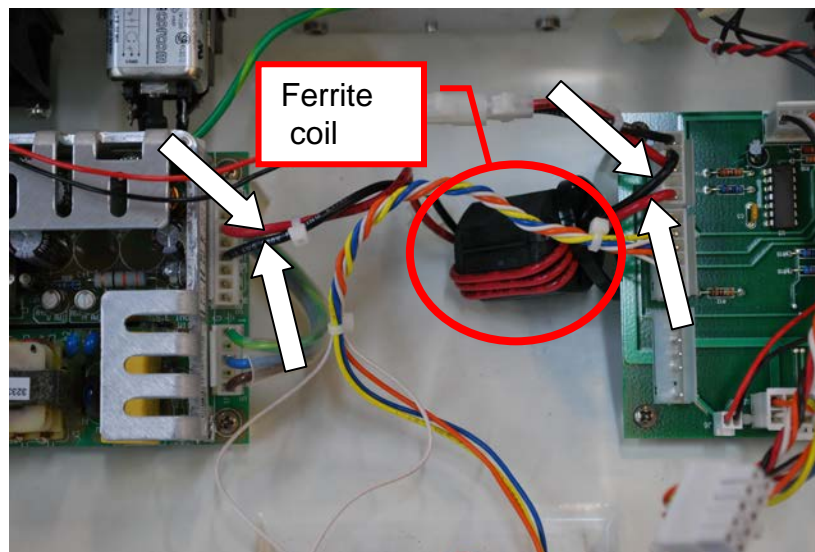
Figure 10 - Location of wires to cut & identification of the ferrite coil.

6. To disable the neoBLUE 2 device, use the wire cutters to cut the black and red wires at both ends between the power supply PCBA and the constant current PCBA as shown by the white arrows in Figure 10.

7. Remove the ferrite coil, and return to Natus with the Serial Number label and the photograph of the Serial Number as physical evidence that the unit is disabled.
8. Dispose of all neoBLUE 2 light components in accordance with existing customer practice and local regulations for disposal of electronic waste.
