**Follow-up Communication****Urgent Field  
Safety Notice**02<sup>nd</sup> August 2017

<b>Product Code</b>	<b>Product Description</b>	<b>Lot Number</b>
114533	Artiset HD SN HC	Lot 1634 and onwards

**Problem  
Description**

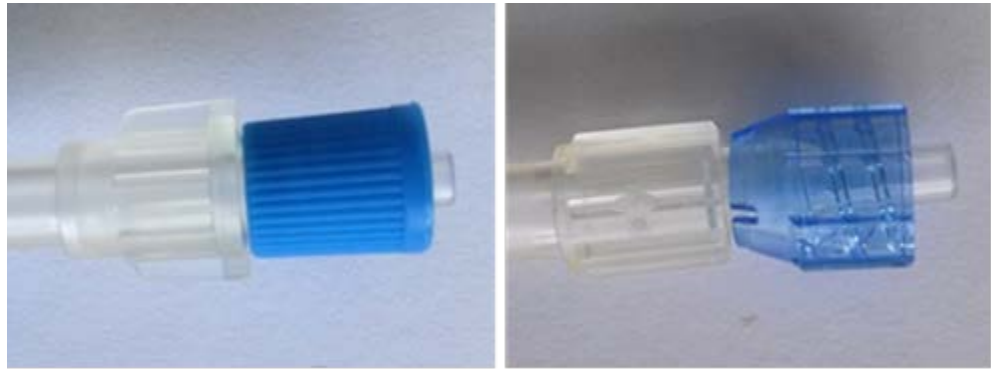
*Patient connector involved in this field action  
(lots listed above through lot 1723)*

*Original patient connector*

- Coupling nut (blue end piece): the original connector is slightly transparent with a different shape and is movable in axial direction.
- Wings of the body (clear piece): no wings are present on the original connector.

With the aim of increasing effectiveness of the corrective action, a decision was taken by Baxter to reintroduce the original patient connector design implemented in ArtiSet bloodlines, before the introduction of the patient connector design involved in this Field Action. Bloodlines with the original patient connector design will be reintroduced starting with lot number 1724. Baxter will not be updating the Bloodlines Instruction for Use as the connectors affected by this field action (lots listed above through lot 1723) are no longer being produced.

For your reference, the patient connector involved in the FA and the original patient connector (which will be reintroduced on ArtiSet bloodlines) can be distinguished based on some visual differences explained below.
