URGENT – FIELD SAFETY NOTICE
Concerto & Basic shower trolley

Date:	2019-MMM-DD
Product Issue:	Concerto & Basic shower trolley – Potential unintentional drop of safety side panel
Affected Product:	<ul style="list-style-type: none"> ✓ Concerto & Basic shower trolleys manufactured between November 2018 and June 2019; Serial number ranges: P0512263 to P0551621 ✓ Concerto & Basic shower trolleys fitted with the affected spare parts (safety catch) part no. 8451622, 8546608, S8533571-031, S8533572-031, S8533570-031 S8542201-014, S8523559-031, 100-805-03, 100-806-03 during service between 2019-Nov-27 and 2019-Jun-14
Affected Serial No.:	Customer specific – will be provided for each customer
Resolution:	Safety catches replacement in order to ensure the device is operating safely
Field Safety Notice:	FSN-POZ-002-2019
Pages:	4

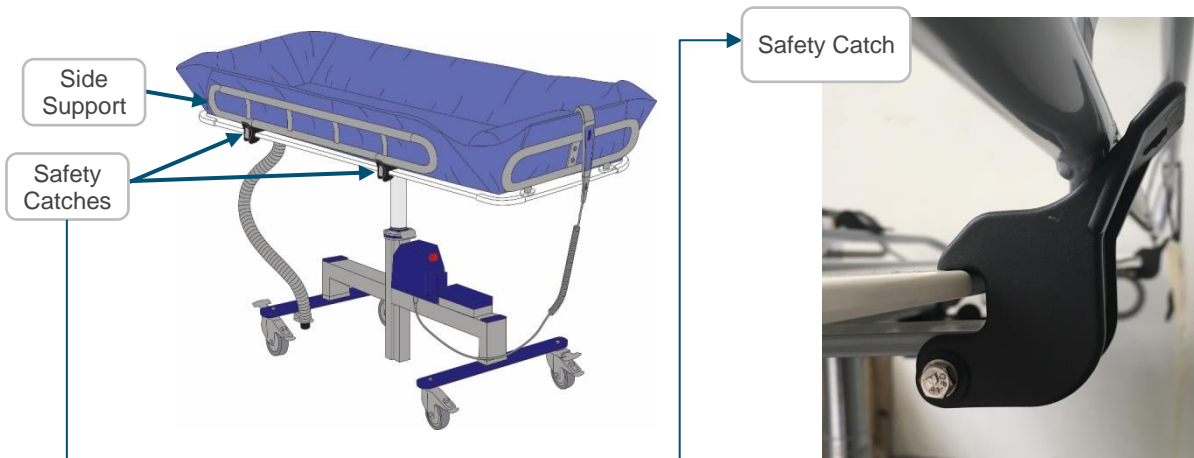
Image 1

Each Concerto & Basic shower trolley is equipped with two Side Supports, one on each side of the shower trolley (Image 1). Each side support is secured by two (2) Safety Catches (Image 2) which are used to fold down the supports as well as secure the support in the raised position.

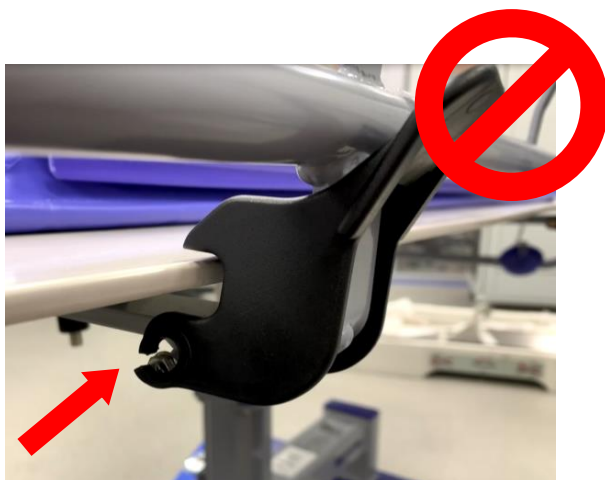
Image 3

Arjo has become aware that any of the 4 Safety Catches may exhibit a mechanical failure (break in one of the arms of Safety Catch), which in certain circumstances may contribute to the Side Support unintentionally opening and may lead to a potential risk of patient fall, leading to possible injuries to patient and/or caregiver.

Until the day of the safety-related corrective action launch, Arjo has received six incidents with this failure mode where one (1) out of four (4) Safety Catches broke. Although the likelihood of an adverse injury or event is limited, Arjo is taking this matter very seriously and intends to perform corrective action on the affected units.

1. Verify the condition of all 4 Safety Catches attached to your device. If you notice the break (as shown in Image 3) withdraw the trolley from use.

IMPORTANT: The device may stay in use until the upgrade is performed, providing that the following instructions are carefully followed:

- ✓ It is recommended that the Safety Catches on the shower trolley Side Supports be inspected daily to ensure any of the catches are not broken as show on the Image 3.
