Urgent Field Safety Notice (FSN)

CU-SP1, CU-SP1 AUTO

Battery Meter Issue

FSCA Ref: CU-FSCA-24-01-01

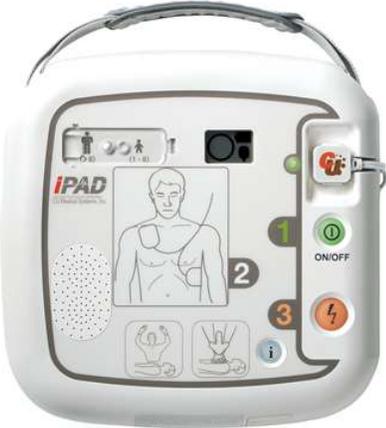
<p><CU-SP1></p> </div> <div style="text-align: center;">

1. Information on Affected Devices*	
1	<p>1. Device Type(s)*</p> <p>The CU-SP1 series is semi-automated external defibrillators (AED) and the CU-SP1 AUTO is a fully automated external defibrillator (AED). If connected to a patient, it automatically acquires and analyses the electrocardiogram (ECG) of the patient for the presence of Ventricular Fibrillation or Ventricular Tachycardia (also known as shockable rhythms).</p> <div style="display: flex; justify-content: space-around; align-items: center;"> <div style="text-align: center;">

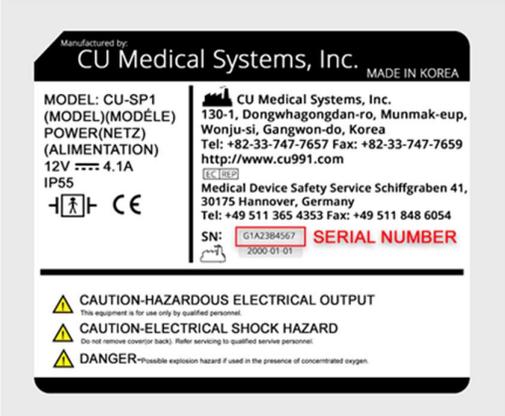
Type of Action to mitigate the risk*			
3.	<p>1. Action To Be Taken by the User*</p> <p style="text-align: center;"> <input checked="" type="checkbox"/> Identify Device <input checked="" type="checkbox"/> Return Device </p> <p>Step 1 – Identify the serial number and model name.</p> <p>The model name, date of manufacture and serial number are presented on the label attached on rear of the unit. Use this device information to fill the form.</p> <div style="text-align: center;">

</div> <p>Step 2 – Find the serial number in the serial number list on Appendix to see if your device is one of the affected units.</p> <p>Step 3 – Fill the electronic form by visiting https://tally.so/r/w2PaID to register your device.</p>
