URGENT FIELD SAFETY NOTICE

GEHC Ref# 32072

RE: Giraffe Blue Spot PT Lite Phototherapy Systems—Light Output May Fall Below the Recommended Minimum Output Due to Fiber Protrusion.

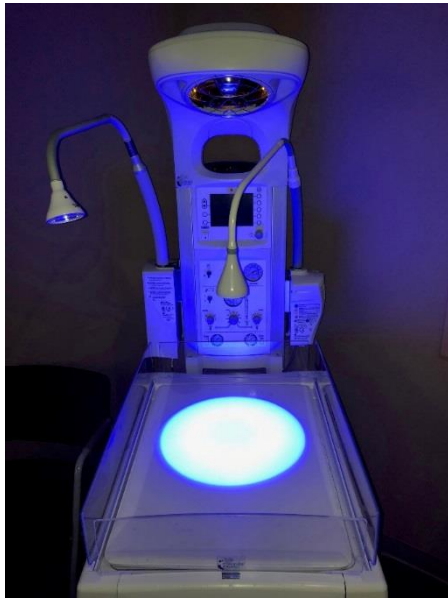
Normal / Focused Output Light

Elevated heat can cause the light pipe optical fiber to protrude through its reflector aperture, creating an unfocused spot with less than $27\mu\text{W}/\text{cm}^2/\text{nm}$ output as described above. The photos below show the effect and can be used in conjunction with the BiliBlanket Meter II bilimeter to identify units with a low light condition due to elevated heat exposure.

Shade is 15 in. (38 cm) from mattress pad
 Output has well-defined edges
 Output is a 14 in. (35.5 cm) dia. circle
 Light intensity uniform

Take out of service any units found to have irradiance levels less than $27\mu\text{W}/\text{cm}^2/\text{nm}$ and await the free kit to correct the unit that GE Healthcare will be sending for all potentially affected units.

To correct any existing devices experiencing low light output due to fiber protrusion and to prevent potential future low light output due to fiber protrusion, **GE Healthcare will send a kit to fix all potentially affected units free of charge** beginning early February 2020. The kit will include the replacement shade with installation instructions. A resident biomed technician can easily and quickly install the replacement shade in a few minutes. For devices with fiber protrusion and outputs below $27\mu\text{W}/\text{cm}^2/\text{nm}$, this replacement will bring your device's back to a factory new output between $36\mu\text{W}/\text{cm}^2/\text{nm}$ and $56.25\mu\text{W}/\text{cm}^2/\text{nm}$. The kit will also include a Preventive Maintenance addendum to the existing Operation, Maintenance, and Service Manual.

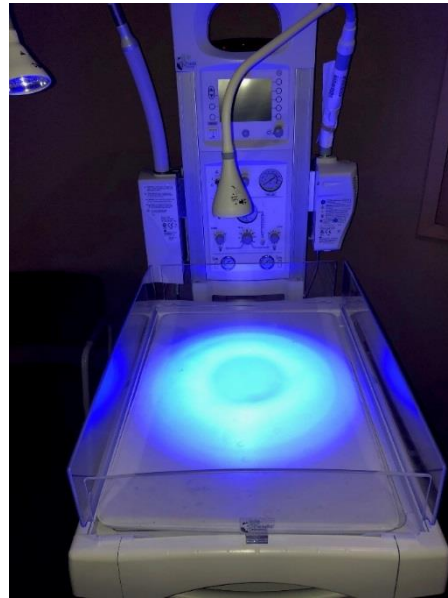
Abnormal / Unfocused Output Light

Shade is 15 in. (38 cm) from mattress pad
 Output has diffused, ill-defined edges
 Output is a 16-19 in. (40.6-48.2 cm) dia. circle
 Dull center surrounded by an intense band

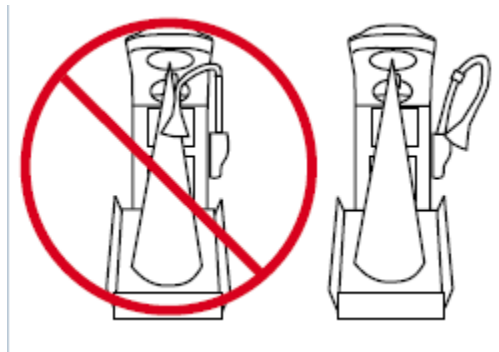
- As previously stated, exposing the shade head to elevated heat from the warmer is contra-indicated with this device. To prevent potential damage to light pipes due to elevated heat, we remind that care should be taken to position the light pipe, as shown in the Instructions for Use Section 2.2 "Operation" and in the Quick Reference Guide, keeping the light pipe Shade head outside the direct path of warmers (see figure below).

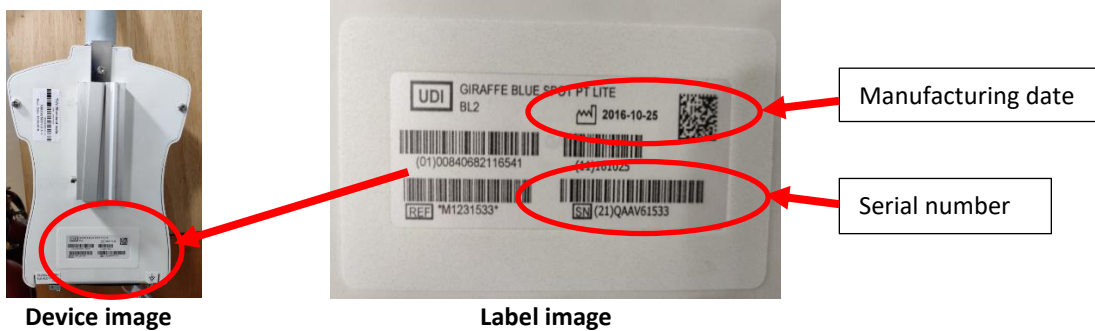
Location of System Serial number and year of manufacturing

System serial numbers beginning with QAAT, QAAU, QAAV, QAAW and QAAX from QAAX60001 to QAAX60155.

System GTIN numbers are 00840682116572 and 00840682116541.

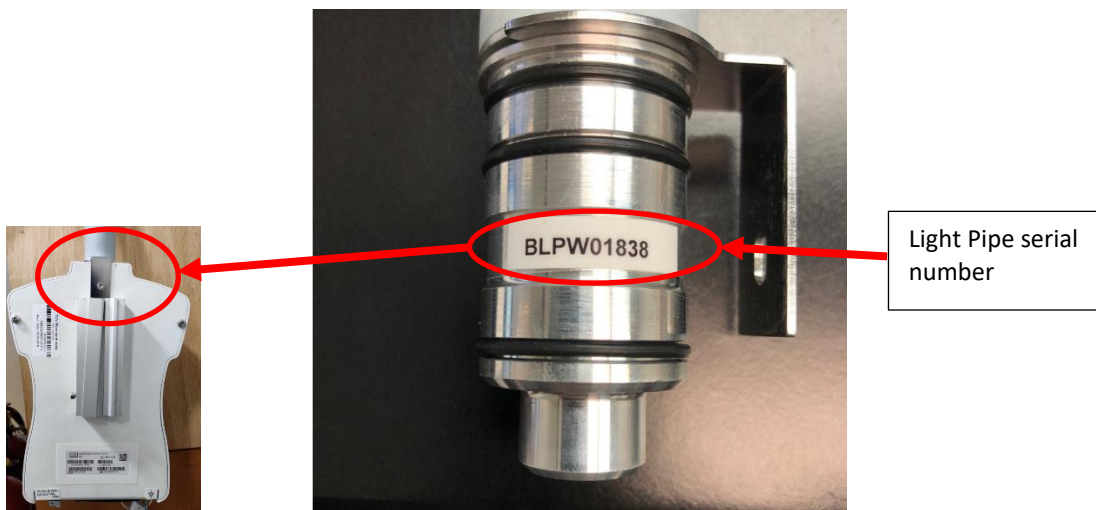
Light pipe serial numbers beginning with BLPT, BLPU, BLPV, BLPW and BLPX from BLPX00001 to BLPX00243.

To locate the Light Pipe serial number, remove the light pipe by referring to Service Manual Section 7.4.1

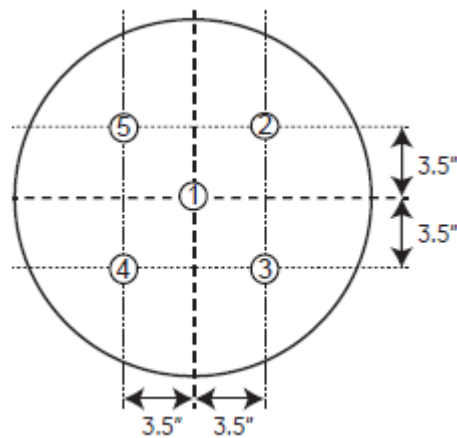
Figure 2-1 Light Measurement Points

1. Connect the power cord to an appropriate power source. The standby/on indicator will light green to indicate standby mode.
2. Press the standby/on switch to turn on the therapeutic light. The standby/on indicator will change from green to blue and the over-temperature/under-temperature indicators will briefly illuminate.
3. Keep your hand close to the exhaust vent when the device is on to feel the air flow coming out of the device to confirm that the fan is operating.
4. Focus the therapeutic light so that the spot diameter is 35.5 cm or when the shade is 38 cm from the bed surface.
5. Using a calibrated Biliblanket Light Meter II, measure the light at the 5 points indicated in Figure 2-1 and calculate their average. Confirm that the average is at least $27 \mu\text{W}/\text{cm}^2/\text{nm}$.

6. Divide the lowest reading by the highest reading. If the LED light is functioning properly, the result should be greater than 0.4. If the result is not greater than 0.4, contact service.
