**Medical Device – Advisory Notice**

<b>Name of the product</b>	<b>Reference</b>	<b>Batch</b>
OPTIGUN RATCHET	4195	0101296012
OPTIGUN RATCHET US	419500	0101296012

This Advisory Notice is to inform you of an issue Biomet France is facing with the pin which maintains the knob button in relation to the following products :

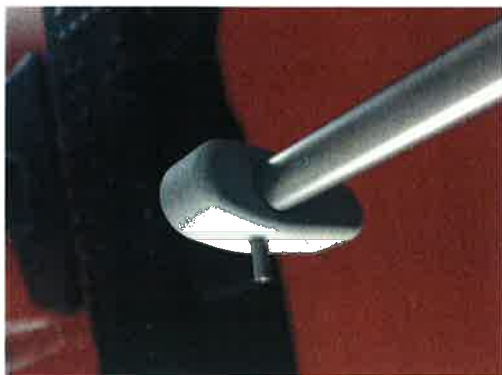
Picture 1

Biomet France has initiated this action after having receiving a number of complaints indicating that the pin which maintains the knob button felt down and the knob button was disconnected from the axis of the Optigun (see pictures below).

The investigation performed by Biomet France revealed that the diameter of some Optiguns rack holes in which the pin is inserted is out of specification.

Biomet France ask you to check the maintaining of the pin before using of the Optigun with applying light pressure on pin. If you identified any item with defective pin from the affected item/lot combination, please contact your local Biomet Distributor as soon as possible for replacement.
