## URGENT FIELD SAFETY NOTICE

Leica M525 F40 Surgical Microscopes

FSCA-Identifier: CAPA-2017-05-001-H

Adherence to Warnings required during Transportation and Positioning in the OR of the M525 F40

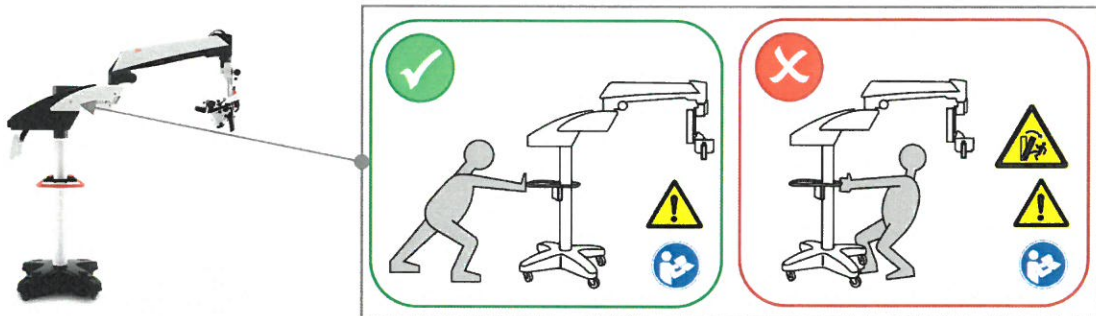
New, additional warning stickers for positioning in the OR (i.e. for minor distances, e.g. within a room):

Picture 1a: M525 40 in use position

Picture 1b & 1c: Warning labels for Leica M525 F40 positioning in the OR (new, in addition)

This is to inform you that Leica Microsystems has introduced additional warning stickers on the Leica M525 F40 (refer to picture 1a, 1b, 1c). In addition, Leica Microsystems provides a „quick reference guide for transportation and positioning in the OR“ for the M525 F40 which can be attached to the instrument (refer to Appendix 1).

You can continue to use the system according to your M525 F40 User Manual. Please ensure, that only trained staff will be using your M525 F40 in order to ensure the instrument is transported, positioned and used as intended according to the instructions for use (refer to pictures 1a, 1b, 1c and 2a, 2b).

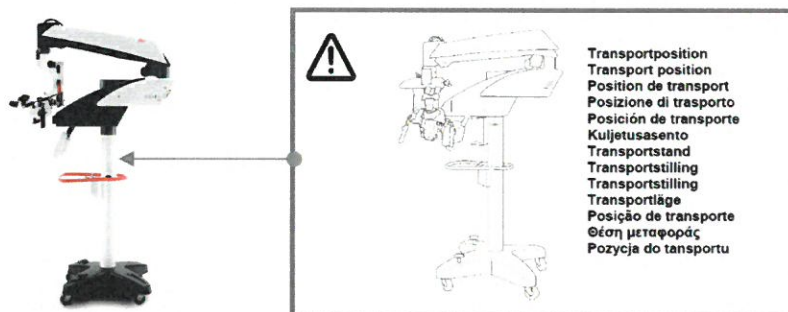
Existing warning label for transportation (i.e. over significant distances, e.g. from one room into another):

Picture 2a: M525 F40 in transport position

Picture 2b: Warning label Leica M525 F40 transport position (existing)
