Reference: 92201802-FA

Field Safety Notice - Important Medical Device Information
Capio™ Suture Capturing Devices (SLIM, Standard, Open Access, RP)
Uphold LITE with Capio™ SLIM Vaginal Support System
Pinnacle™ Anterior Pelvic Floor Repair Kit
Pinnacle LITE Posterior with Capio SLIM Pelvic Floor Repair Kit

Root Cause Investigation:

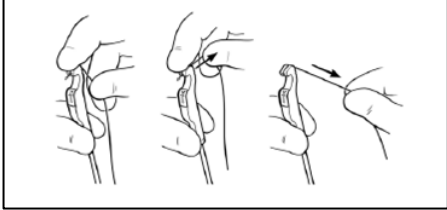
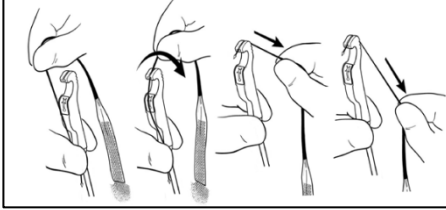
Prior To Deployment	
Capiro Family of Products	Pelvic Floor Kits

<p>Note: When loading a dart into the device, verify that the dart is properly positioned in the carrier. The tip of the dart should not protrude from the Capiro Device tip.</p>	<p>Note: When loading a dart of the leg assembly into the device, verify that the dart is properly positioned in the carrier. The tip of the dart should not protrude from the Capiro Device tip.</p>

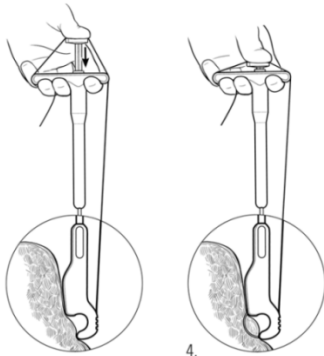
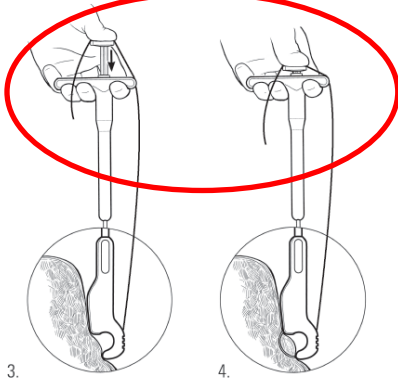
Capiro Family of Products Deployment Technique Tips	
Existing Capiro Family Directions For Use	Updated Capiro Family Directions For Use

<p style="text-align: center; font-size: small;">Avoid excessive counter-traction that would prevent free movement of the suture during deployment</p>
<p>Existing DFU Technique Tip: “During use, secure suture with thumb to maintain adequate (dart) tension in the carrier.”</p>	<p>Updated DFU Technique Tip: Use slight counter-traction on the suture while positioning the Capiro tip, in order to maintain the position of the dart in the carrier. Avoid excessive counter-traction on the suture as this has the potential to damage the suture during deployment. Note: The technique of maintaining slight counter-traction on the suture is best described as placing just enough tension on the suture to keep the dart in the carrier. Excessive counter-traction is best described as preventing free movement of the suture during deployment.</p>

If the Capio suture or pelvic floor kit mesh assembly is placed under excessive counter-traction during deployment, it can result in an interaction between the suture and the Capio carrier that could potentially damage the suture and may cause the dart to detach. The testing confirmed that higher amounts of counter-traction (tension) placed on the Capio suture or pelvic floor kit mesh assembly during deployment contributes to an increased likelihood of damage to the Capio suture and potential Capio dart detachment.
