URGENT: FIELD SAFETY NOTICE – MMS-20-3862

**BD Alaris™ GP Plus; BD Alaris™ GP Plus Guardrails;
BD Alaris™ neXus GP**

REF / Serial Number: Refer to Table 1

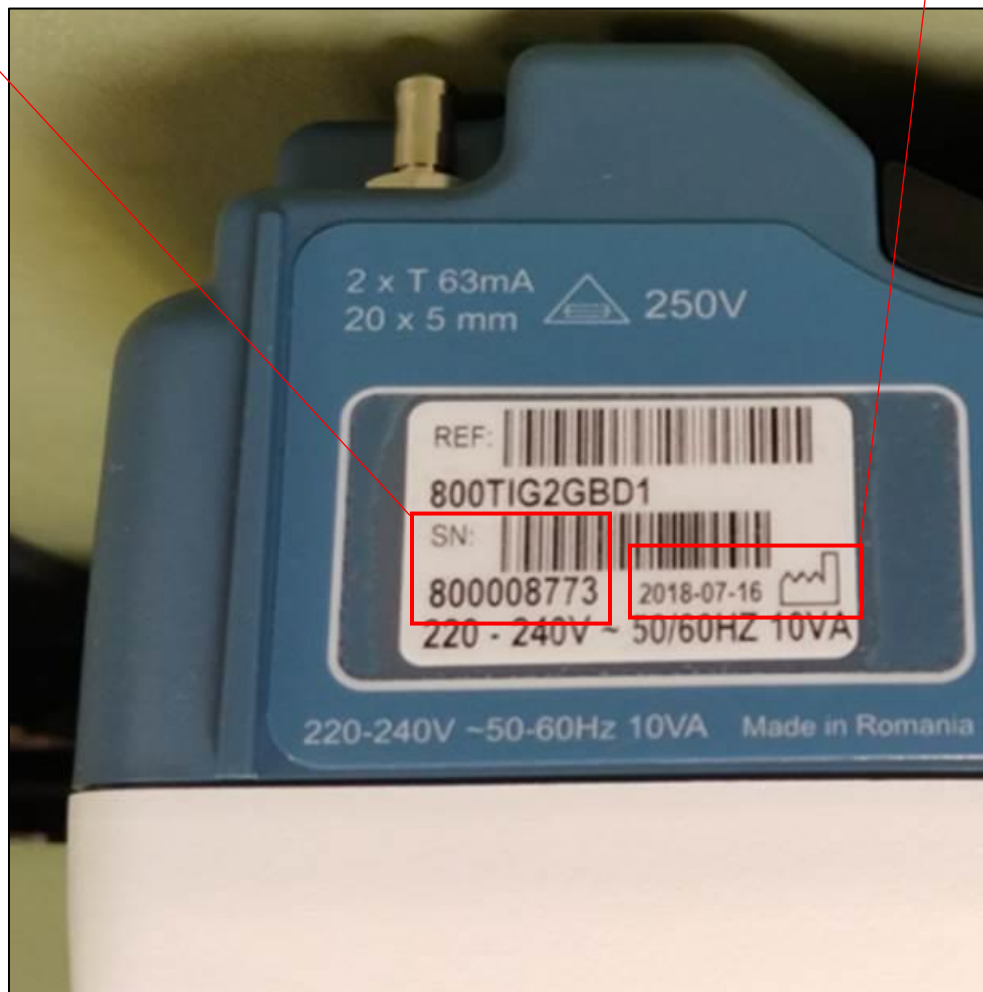
Example of a Pump Label

Serial number and manufacture date can be found as below:

Serial Number

Manufacture Date

2. Please complete the Customer Response form (Page 3) indicating whether you wish the remediation of the instruments to be performed by BD (**Option 1**) or by your organisation (**Option 2**) and return the completed form to BD at BDUKFieldAction@bd.com **no later than 30th November 2020**. An example of a pump label containing the serial number and manufacture date can be found in Appendix 1.
