**Field Safety Notice - 0007**

**Name of Products:-** Prism P136, C136 & CP136

**Prism Reference:-** FSN 0007

**Action:-** Test overspeed mechanism

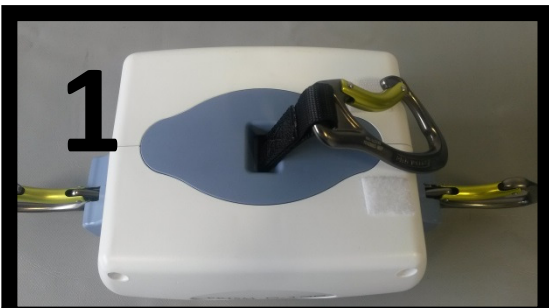
1. Ensure the lift tape is fully wound in to the hoist - **Image 1**
2. Remove small blue cover by removing nut on the toggle switch - **Image 2**
3. Loosen the 4 cover screws and remove 2 white side covers - **Image 3 & 4**

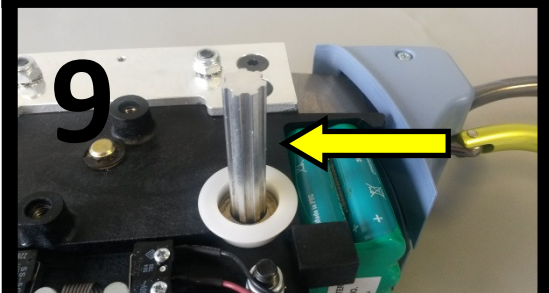
4. Carefully lift and remove blue insert cover - **Image 5**
5. Unplug batteries, lift motor and limit switches - **Image 6**
6. Remove PCB - **Image 7**

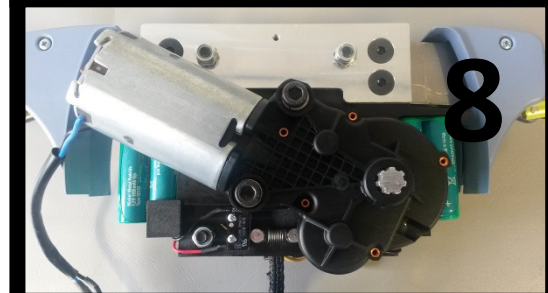
10. Manually wind the hoist up to release the overspeed mechanism - **Image 11**
11. Replace the lift motor (ensure cable is routed correctly) - **Image 12**

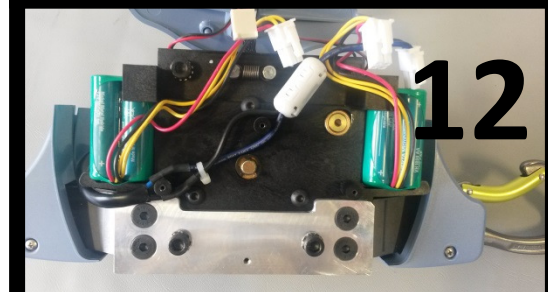
12. Replace PCB and connect batteries, lift motor and limit switch connectors (ensure cables are routed correctly)
13. Replace blue insert cover
14. Place an FSN inspected label on the hoist chassis - **Image 13**

**NOTE:** Only place FSN label on chassis if hoist is to remain in service
15. Replace 2 white side covers
16. Replace small blue cover
17. Test the functions of the hoist including - UP/DOWN, Emergency Lowering & Charging

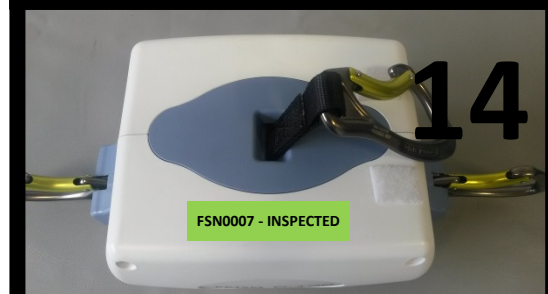
18. Place FSN label on hoist cover - **Image 14**
19. Place hoist back in to service and log the serial number
