Urgent Field Safety Notice

Medtronic Model 37751 Recharger included in Model 37754 and 97754 Charging System

Important Device Information related to Spinal Cord Stimulation

Medtronic reference: FA735

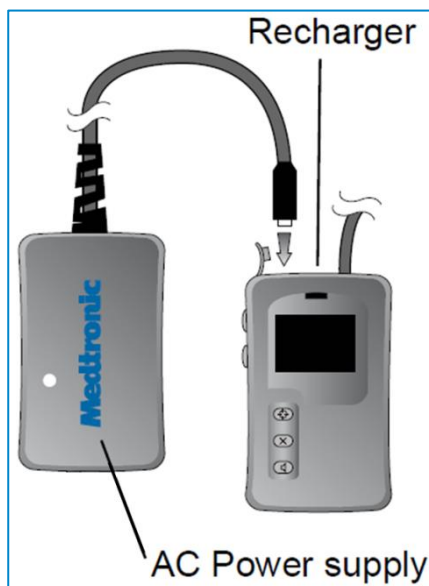
Figure 1

1. In order to prevent this unresponsive error state, the Recharger should be plugged into the AC power supply (by aligning white triangles) prior to begin a recharging session of the neurostimulator and the Recharger should remain connected to the AC power supply until the recharging session is complete

(see Figure 1). Note: The AC power supply does not need to be plugged into a power outlet if the Recharger is charged.

2. If the Recharger is not connected to the AC power supply during a recharging session of the neurostimulator, the unresponsive error state may occur. In this situation, Medtronic requests that you assist patients with a reset of their Recharger by following the reset instructions enclosed. Note: This issue can recur after reset if the recharging instructions are not followed.

- To ensure this issue does not occur, Medtronic recommends all affected patients follow the recharge practice explained above. Keeping the Recharger plugged into the AC power supply during recharging will prevent this error state from occurring.
- If you are contacted by a patient with a Recharger in an unresponsive error state, you can assist the patient with a reset of their Recharger by following the reset instructions enclosed.
- Medtronic is working on a permanent solution for this issue. Until this solution is in place, as appropriate please discuss this notification and the issue mitigation with your current and new patients implanted with a rechargeable neurostimulator to ensure they understand the mitigations to prevent this issue and the steps required to resolve the issue if it occurs. The enclosed patient notification can be used to facilitate this conversation as needed.
