Bulletin No: T1032
Date: 13 April 2006

TECHNICAL BULLETIN

REA ASSIST ARMREST ATTACHMENT FAULT

REA ASSIST ARMREST REPAIR PROCEDURE

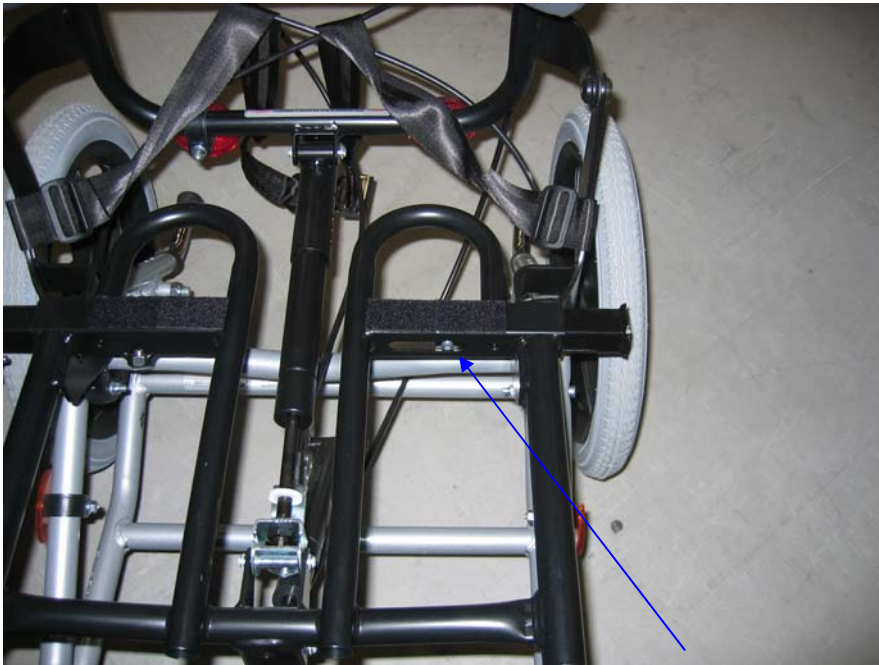
I. Start with removing the seat cushion and the seat plate and then swing the wheelchair backwards all the way to the ground. Remove the screw that the arrow points at in the picture below, which will allow you to pull the tube all the way out. Use a Phillips® screwdriver to unscrew it.

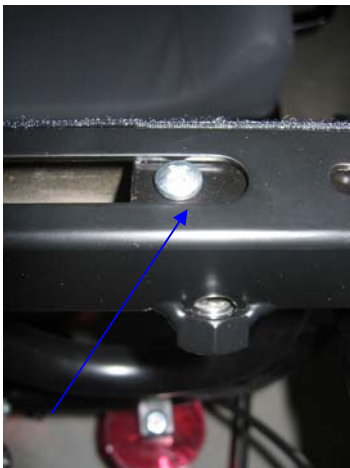
I.I Below is a more detailed picture on the screw that we are referring to above.

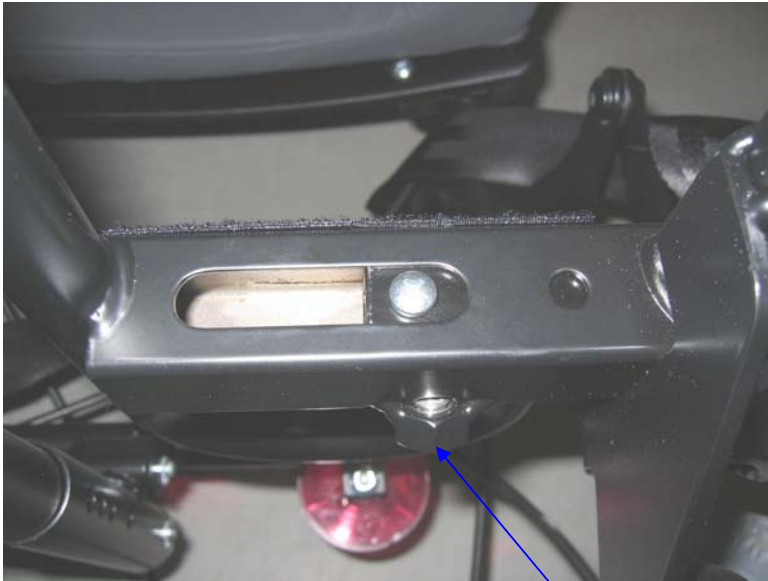
2. Loosen the screw on the opposite side of the tube in relation to the screw in item number one above. Just loosen it a few turns using an Allen key and then it will be possible to pull the tube all the way out and replace it with the new one. The blue arrow in the picture below indicates the cover for the screw.

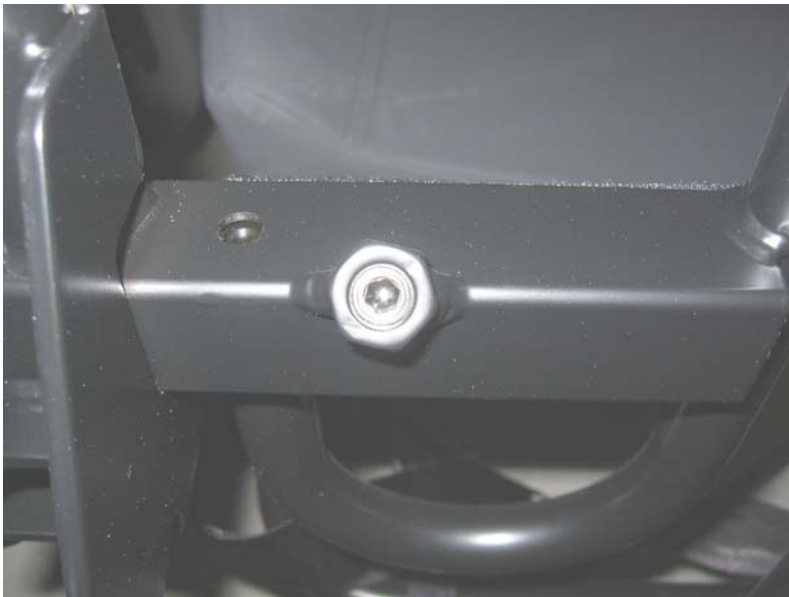
2.1 Below is a more detailed picture on the screw that you have to loosen with an Allen key.

3. Once the replacement parts have been attached, please ensure all screws are re-tightened.
