## Urgent Field Safety Notice

### Flamingo Hoist - Replacement of Spreader Bars

FSN 016

## Flamingo: New spreader bar attachment

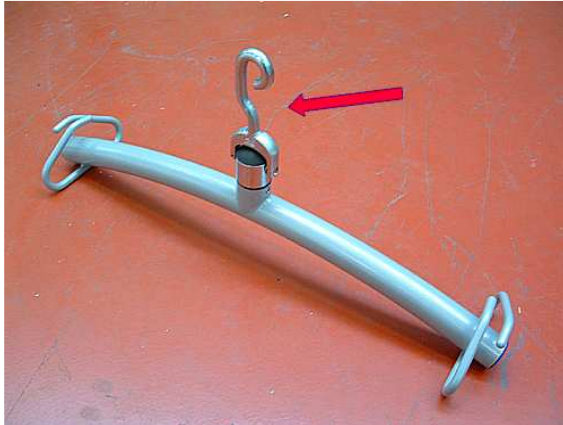
1) Old design: Dismount the old version of the spreader bar from the hoist.

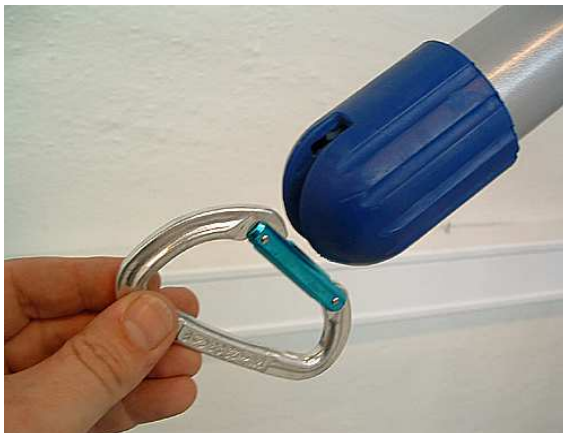
3) Hold the carabiner like shown, with its opening pointed towards the cross pin of the lifting arm. (Widest part of carabiner pointing upwards).

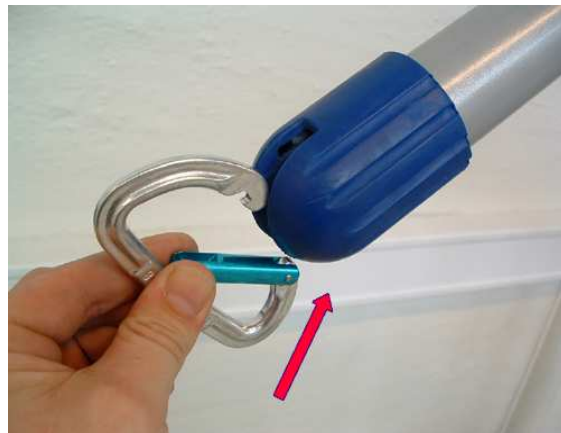
4) Open the safety catch by use of two fingers and press upper part of the carabiner around the cross pin.

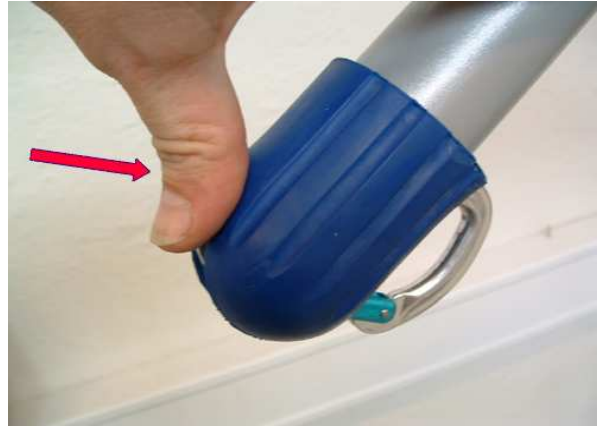
6) Turning the carabiner all the way around the cross pin. (Because of friction between the rubber protection and the carabiner, considerable force may be applied when performing this step.)

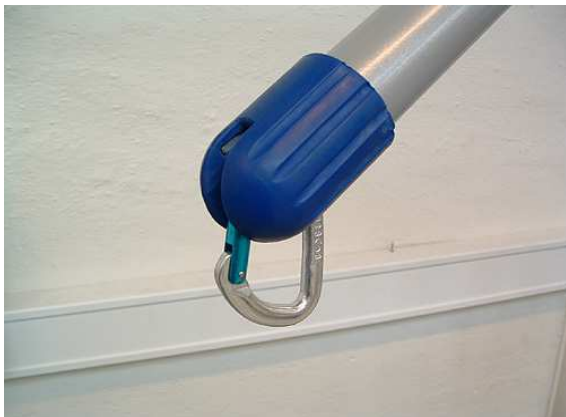
7) Carabiner correctly positioned on the lifting arm, ready for use.

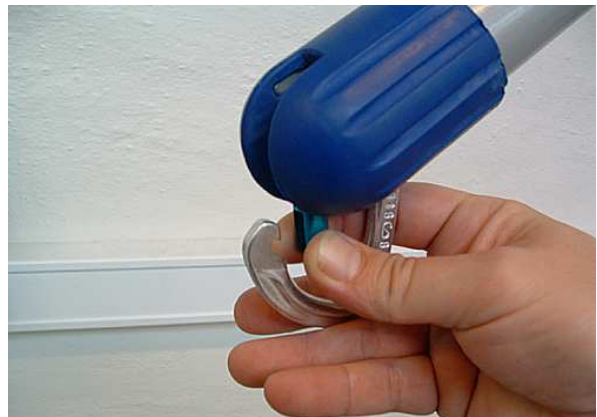
8) Easy opening of the carabiner by pulling the safety catch backwards with two fingers.

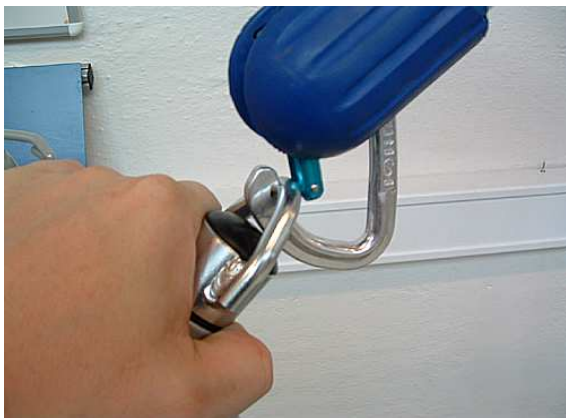
9) Attaching the spreader bar to the carabiner.

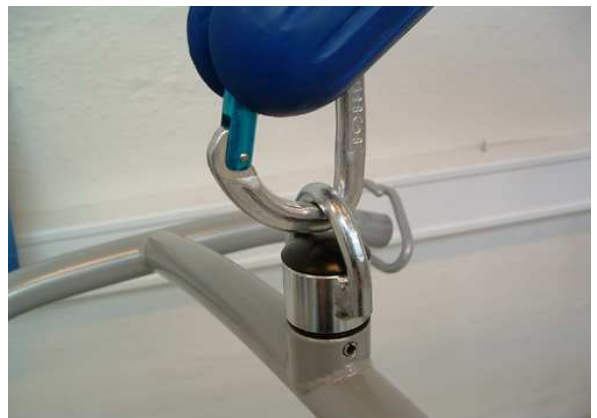
10) Correctly attached spreader bar .
