Urgent Field Safety Notice

Name of product: Hera II (serial numbers 1379 to 2180)

Type of action: Corrective action

Attention: Dealers, clients and users of the Hera II bathing & Toileting chair.

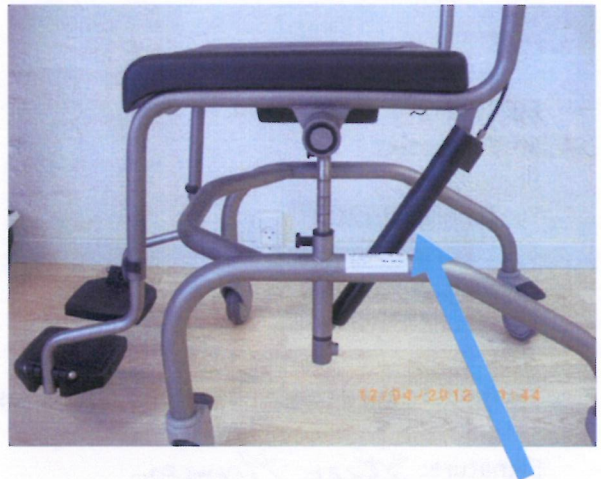
Affected part: Gas spring for tilt function (see photo)

Due to an incident and several claims regarding broken gas springs on the Hera II, and after specific risk analysis, it has been decided that replacement of the gas spring is necessary. The back fixture of the gas spring has been known to break after a significant time of use, resulting in the chair to tilt backwards. If a patient is seated in the chair during this malfunction, there is a risk of the patient hurting the back of the head or getting injured in the neck by the sudden backwards movement! The gas spring has been updated with a reinforced back fixture on products with serial number 2181 and higher. The updated gas spring is compatible to all Hera II and can therefore be used for replacement.

The gas spring on products in question should be replaced as soon as possible or within 12 month. Replacement is shown in the instruction later in this FSN. Gas spring kit for replacement (047-00047) is available through your local dealer or by contacting Ergolet sales. Information regarding the serial number, of the chair, is required to receive the replacement kit for free, or get a credit nota. The gas spring can be mounted by any competent technician by following the instruction.

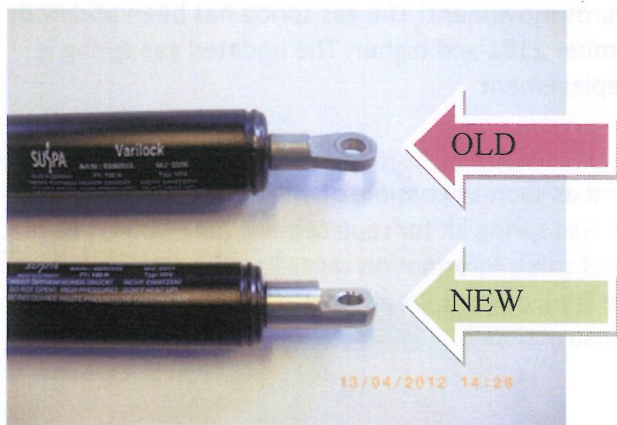
NB: Any gas springs with old type back fixture, in spare part stock etc., must be replaced by gas springs with new type back fixture! – Item number: 047-00041 (see photo)

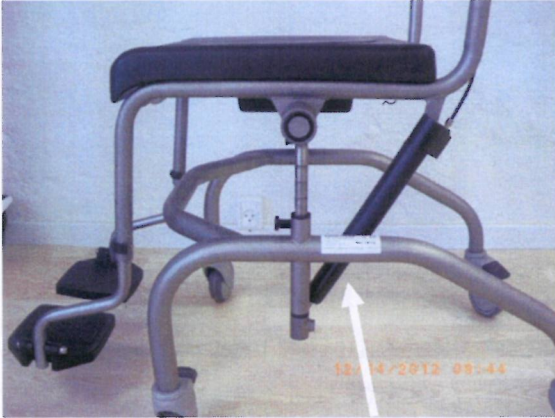
Gas spring to be replaced.

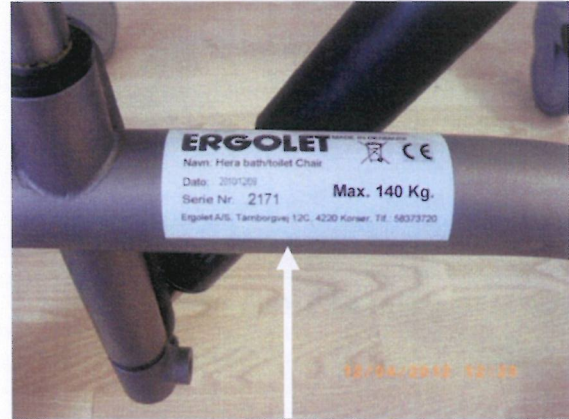
Type plate with serial number.

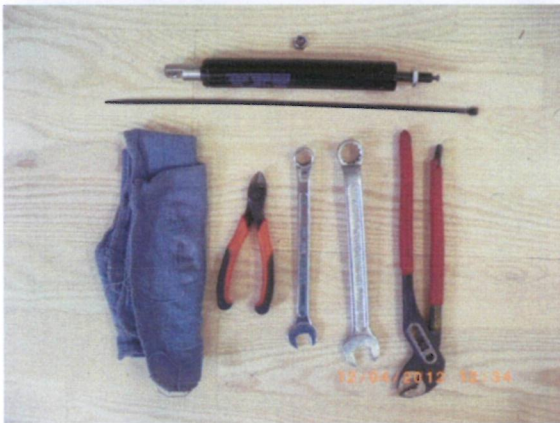
Replacement kit – and tools needed:

Tools needed:

Cloth
Pliers
13 spanner
17 spanner
Poly grab bar

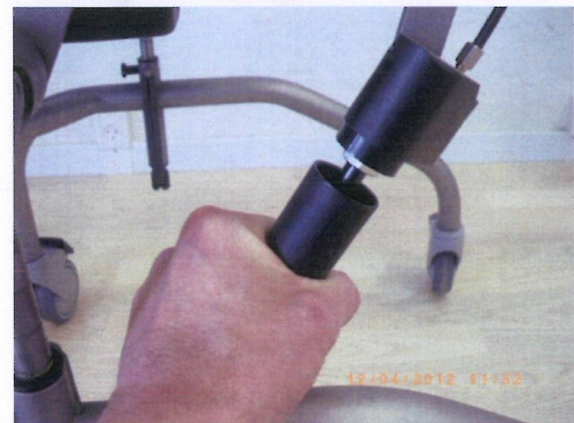
1. Remove the cover tube from the Gas spring top end.

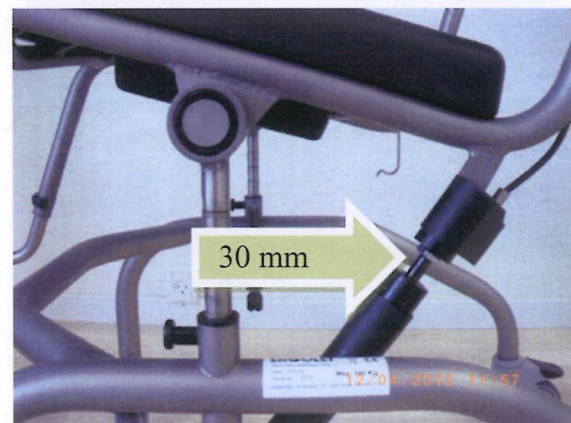
2. Release the gas spring to have 30mm free piston rod, leaving the seat in a backward angle, as in the picture.

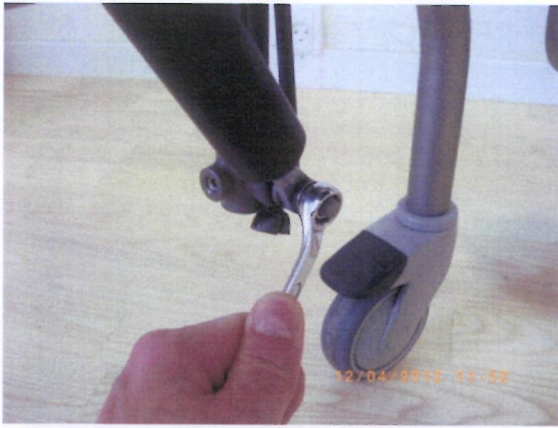
3. Unscrew the M8 lock nut.

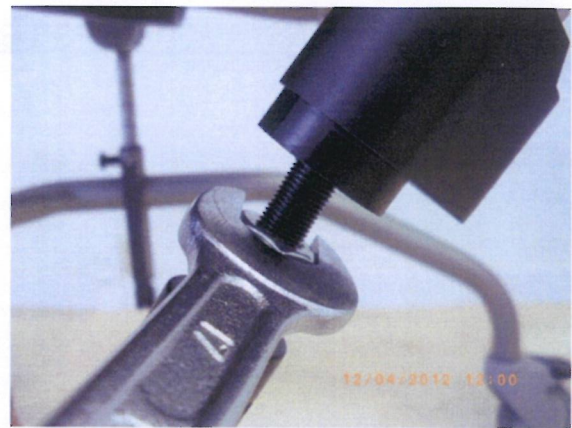
4. Unscrew the M10 nut. Keep unscrewing until the piston rod thread has come out of the plastic housing.

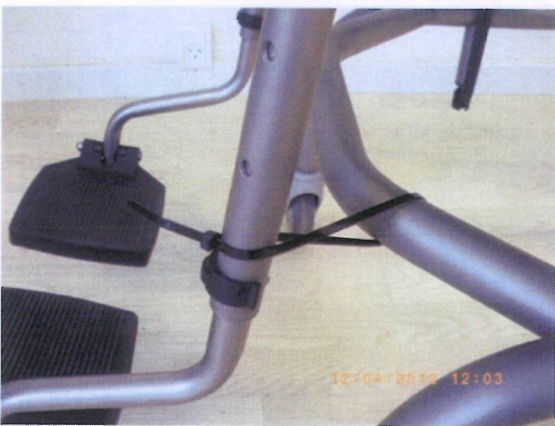
5. Lock the tilt function with a plastic strip to make the replacement easier.

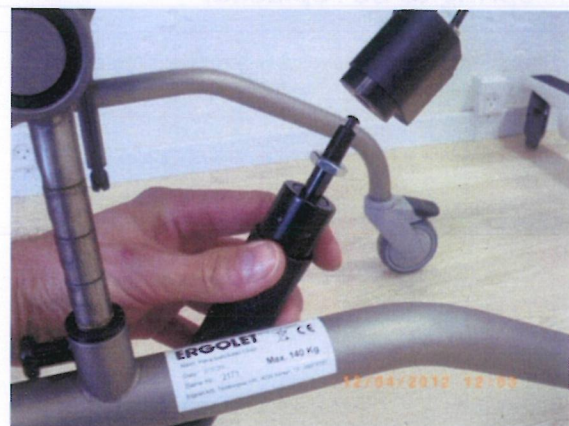
6. Remove the old gas spring.

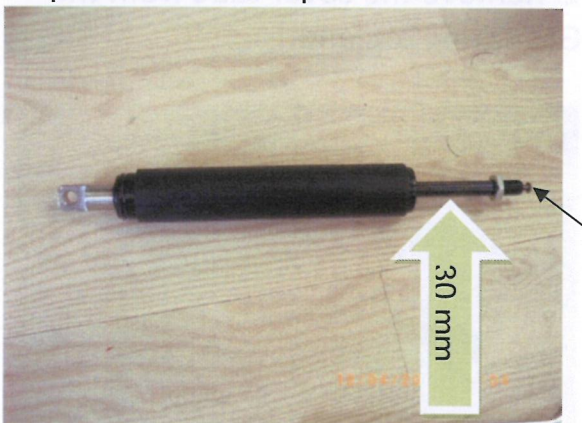
7. Fit the cover tube to the new gas spring in the same direction as on the old gas spring. Release the gas spring to have 30mm free piston rod.

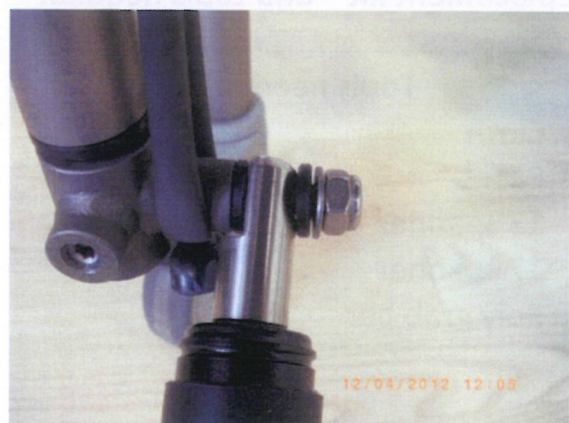
8. Fit the gas spring to the threaded tap at the bottom end.

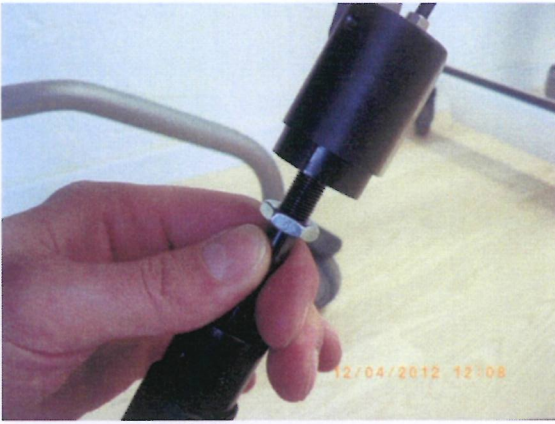
9. Cut the plastic strip and fit the piston rod end to the housing.

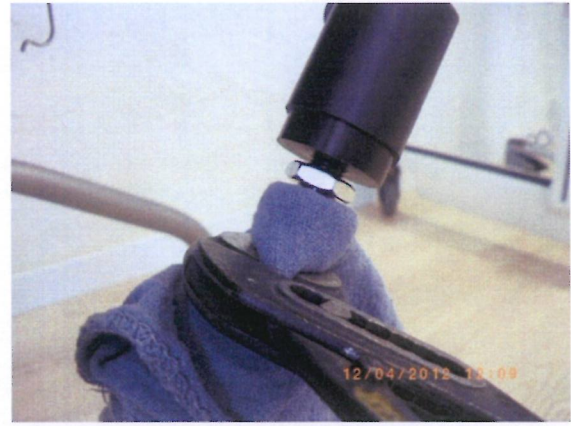
10. Screw in the piston rod until the gas spring is released. Use the cloth to protect the piston rod from scratches.

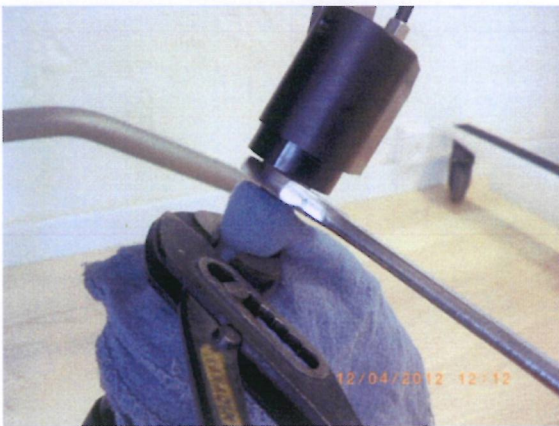
11. Unscrew the piston rod 1 turn* and tighten the M10 nut whilst securing the piston rod.

*Check the gas spring release/lock function in the out, middle and in position!

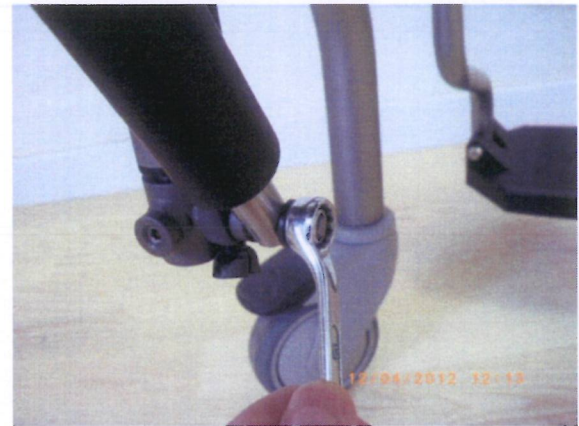
12. Tighten the M8 nut, with little torque, until the thread shows on the outside.

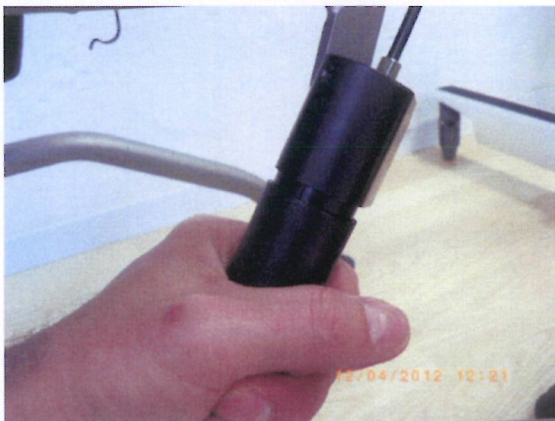
13. Press the cover tube on to the Plastic housing.
