# Counterfeit Covidien Nellcor SpO2 Durasensor® (DS-100A) sensors

**IMB Safety Notice: SN2011(01)**

**Circulation Date: 21 January 2011**

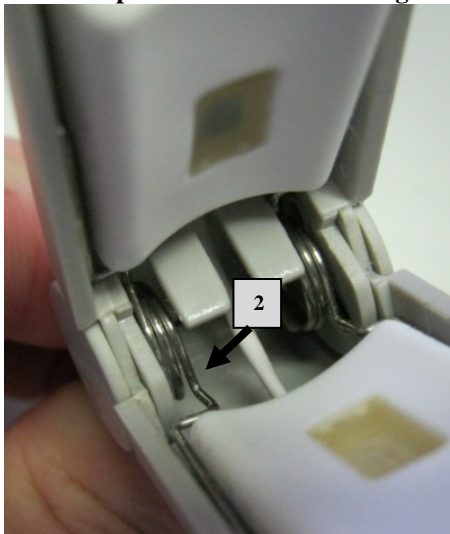
2. **Feather of the sensor (can be seen when sensor is opened)** - The authentic Covidien product has one winding of the feather (figure 3) whereas the counterfeit product has three windings of the feather (figure 4)

Figure 4 Counterfeit product with 3 windings of the feather

- All products in your possession should be checked using the details above to assess whether the product is genuine or counterfeit.
- If from your assessment you determine or suspect that you have product that is counterfeit identify, locate and quarantine all product to ensure it will not be used.
- If you identify that you have product that is counterfeit you should submit the information detailed in Appendix I to the IMB ([enforcement@imb.ie](mailto:enforcement@imb.ie) and [vigilance@imb.ie](mailto:vigilance@imb.ie)). On receipt of this information the IMB will contact you to advise what further course of action is required.

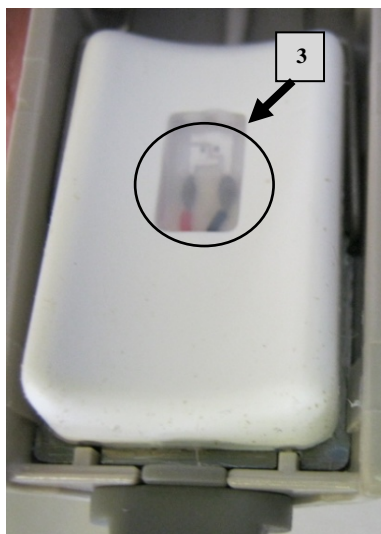
3. **Optical part of the sensor (can be seen if sensor is opened) -** The authentic Covidien product has two visible cables in red and black (figure 5) whereas the counterfeit product has no visible cables (figure 6)

Figure 5 Authentic product with two visible cables in red and black

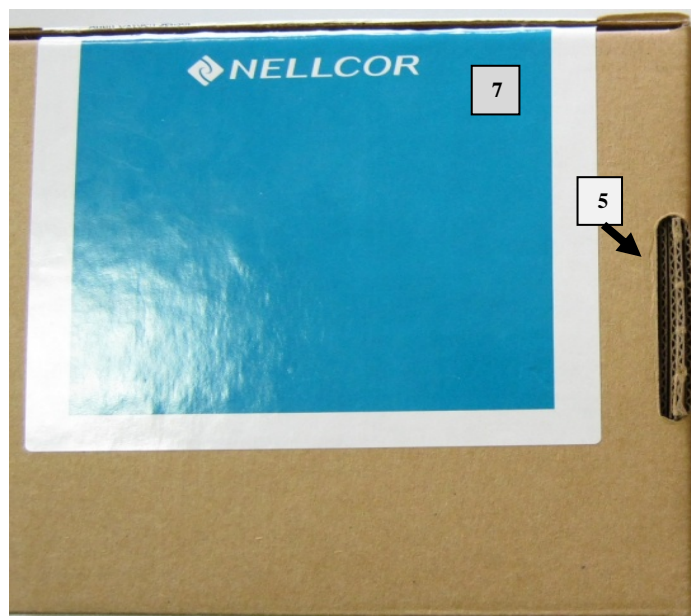
5. **Carton bottom** - The authentic Covidien product has a rounded press cut in the carton round (figure 9) whereas the counterfeit product as angular press cut in the carton (figure 10)
6. **Carton bottom** - The counterfeit product has additional labels where “Handheld Pulse Oximeter-Oxygen Sensor” is printed on and additional bill of materials (figure 10), as can be seen on picture 10 the additional labels indicate that the sensors were manufactured for use out of Europe and the European Union as there are none of the European languages on there.
7. **Carton bottom** - The counterfeit product has a darker background colour (figure 9) than the authentic product (figure 10).

Figure 9 Authentic product
