URGENT FIELD SAFETY NOTICE

GEHC Ref# 32067

RE: Giraffe Bedded Warmer/Panda iRes Warmer - Bedside panels, latch areas may be cracked, broken or damaged.

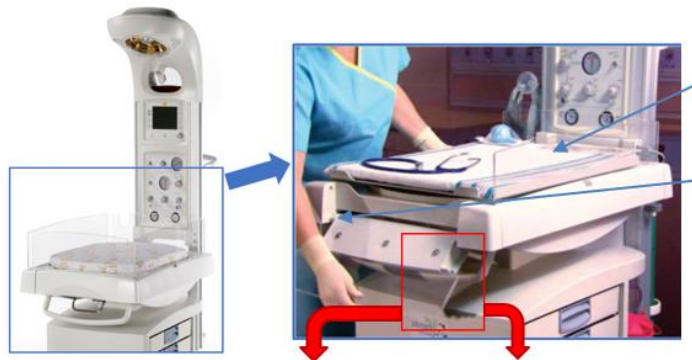
GE Healthcare has become aware that the bedside panels, and latch areas on the warmer can crack or break if the unit is moved using the bedside panels instead of the front handle or the maneuvering handle. If an infant impacts a bedside panel with a cracked or broken latch, the panel can disengage and fall open, no longer protecting the infant from falling from the warmer.

Figure 1A: Bedside panels

Figure 1B: Area connecting panel to bed

1) Inspect the warmer bedside panels (see below Figure 1A) latch areas and the areas connecting the panel to the bed (see below Figure 1B) for any cracks or damages per the addendum included in this mailing. **If any portion of the bedside panels or latches are cracked or broken (see below Figure 1C), stop use of the warmer.** Complete and return the attached response form in Table 1-1, indicating what components require replacement. If the Warmer bedside panels or latches (see below Figure 1D) have no cracks or damage, continue to Safety Instruction 2.

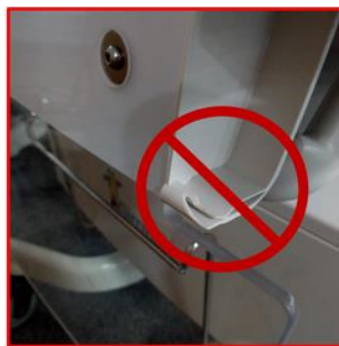
Figure 1C - Broken Latch

GE Healthcare will replace all cracked or damaged bedside panels/latches at no cost to you. Complete and return the attached "Customer Response" form via e-mail to MIC.Recall@ge.com and a GE Representative contact you to arrange for a replacement.

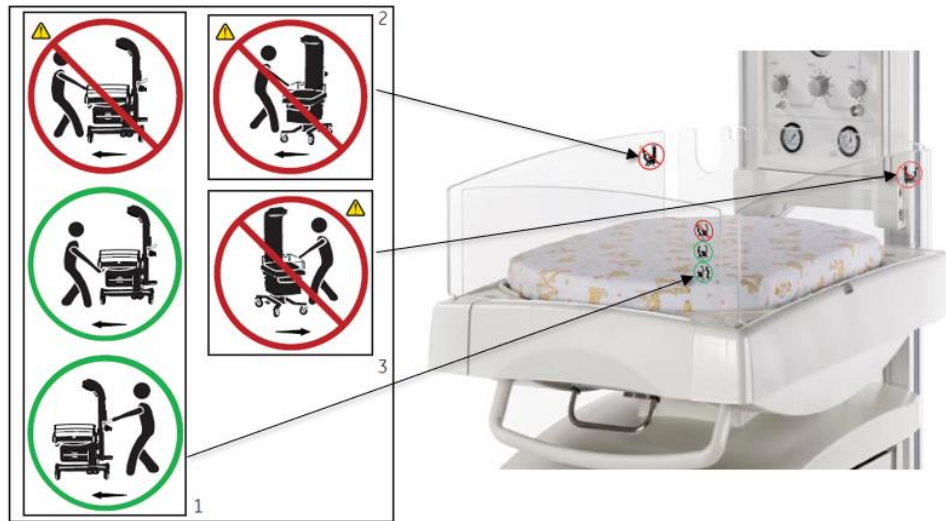
- a) Clean area with a cleaning solution recommended in the Operation and Maintenance Manual.
- b) Wait for the area to dry.
- c) Peel off label 1 and apply it to the front (south) bedside panel at the location shown in the illustration below.
- d) Peel off label 2 and apply it to the left (west) bedside panel at the location shown in the illustration below.
- e) Peel off label 3 and apply it to the right (east) bedside panel at the location shown in the illustration below.

2) If the Warmer bedside panels or latches have no cracks or damage, you may continue to use your warmer. Apply Safety labels included in this mailing to the warmer by following the below instructions:
