# URGENT FIELD SAFETY NOTICE

**Reference:** FSN/16/01

**Product Name:** Steiss Activate Hoists

**Type of action:** Product Safety Notice

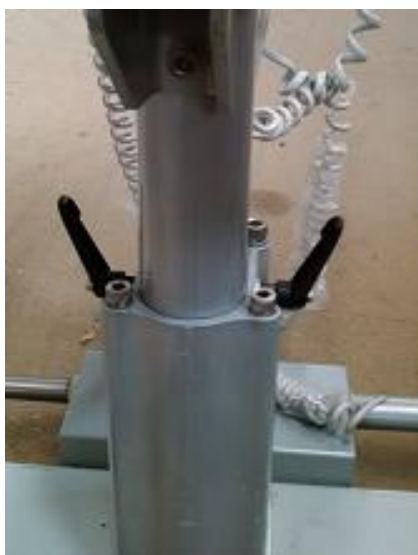
Photo 1

The fixing handle securing the mast location pin which are situated on either the side of the hoist mast through the chassis yoke were facing **upwards** (see photo 1) resulting in an end user unexpectedly suffering a severe gash on the leg.

1. Immediately identify the Steiss Activate models 18 and 13 currently in use and ensure that the handles are facing **downwards**. This is a simple operation that can be undertaken by the

operator by turning the handles to face **downwards**. They are sprung loaded to enable this action at any tension. Simply pull the lever slightly outwards and rotate to the **downward** position. (photos 1 and 2).

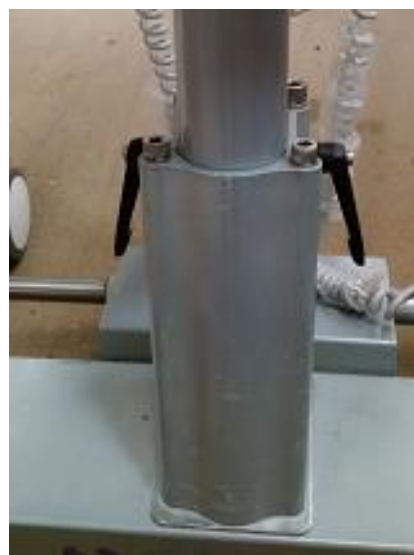
Photo 2

This is the first reported incident since these hoists were placed on the market in 2013. Our quality monitoring system has however identified a medium risk as these handles are required to be facing **downwards** (see photo 2) as they were when the hoists are originally assembled.
