Subject: Important FIELD SAFETY NOTICE (FSN)
FSCA Ref. „FSCA2021-001“

Information about a Field Safety Corrective Action for NIHON KOHDEN Ventilators NKV-550-U

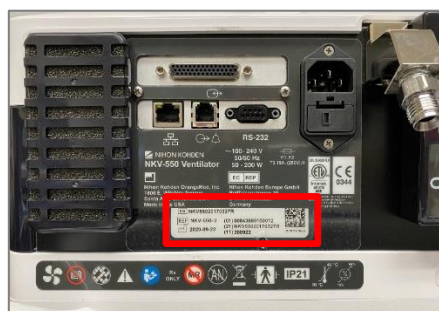
Localisation of the name plate at the rear panel:

The affected ventilator NKV-550-U can be identified by the model's name and serial number on the nameplate on the rear panel of the NKV-550-U ventilator.

[REF] NKV-550-U on the nameplate

[SN] NKV550YYWWssss on the nameplate
 (YY = manufacturing year, WW = manufacturing week, ssss = number)
