URGENT Field Safety Notification

Tempus Pro Monitor
Ingress and Basic Safety Issues

15-FEB-2023

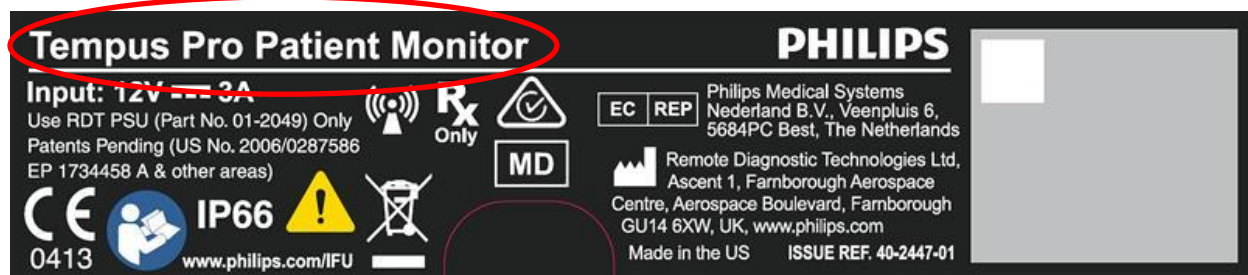
This Correction affects all Tempus Pro Monitor devices. The Part Numbers for Tempus Pro are as follows: 00-1004, 00-1004-R, 00-1007, 00-1007-R, 00-1024-R, and 00-1026-R. Tempus Pro Monitors are identified by a label placed on the rear of the device. An example is shown below:

The product number (REF) and Serial Number (SN) are printed in the gray box.
