URGENT Field Safety Notice

Multiva 1.5T systems Terminal connections in the general Mains Distribution Unit (g-MDU) may produce a Thermal Event

30-May-2024

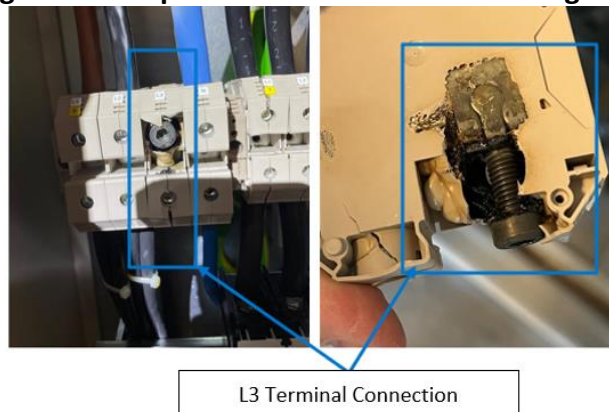
Figure 1. Hotspot on terminal connection of g-MDU

Philips has identified an issue where the g-MDU (global Mains Distribution Unit) L3 terminal connection may become loose creating a hotspot (see figure 1) that may cause smoke/fire to alarm in the hospital's technical room. The g-MDU, located in the technical room, is the single-entry point for the hospital electricity supply and distributes the electricity toward the various cabinets and components of the MR Scanner.

If the connection failure occurs, the user may observe the following:

- Smoke and/or fire alarm in the examination room
- Smoke and/or fire in the hallway or technical room
- Power being cut from the system

Philips will contact you to schedule time for a Field Service Engineer (FSE) to visit your site to inspect the g-MDU connections in the technical room and apply the proper torque to the connection if necessary. (reference FC078100583). Philips plans to start implementing corrections in July 2024.

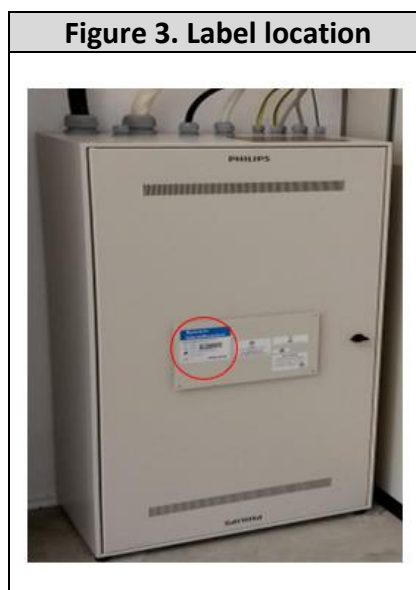
All Multiva 1.5T systems equipped with g-MDU listed below are affected. Refer to Figure 2 for the systems model names and model numbers (REF) and Refer to Figure 3 on how to locate the system label.

- Enter the Technical Room
- Locate the Mains Distribution Unit (gMDU)
- The label is located on the front door of the gMDU, (see Figure 3)
