Safety notification

concerning: SELEXA bed chair

Visual inspection Screws Safety notification SELEXA bed chair

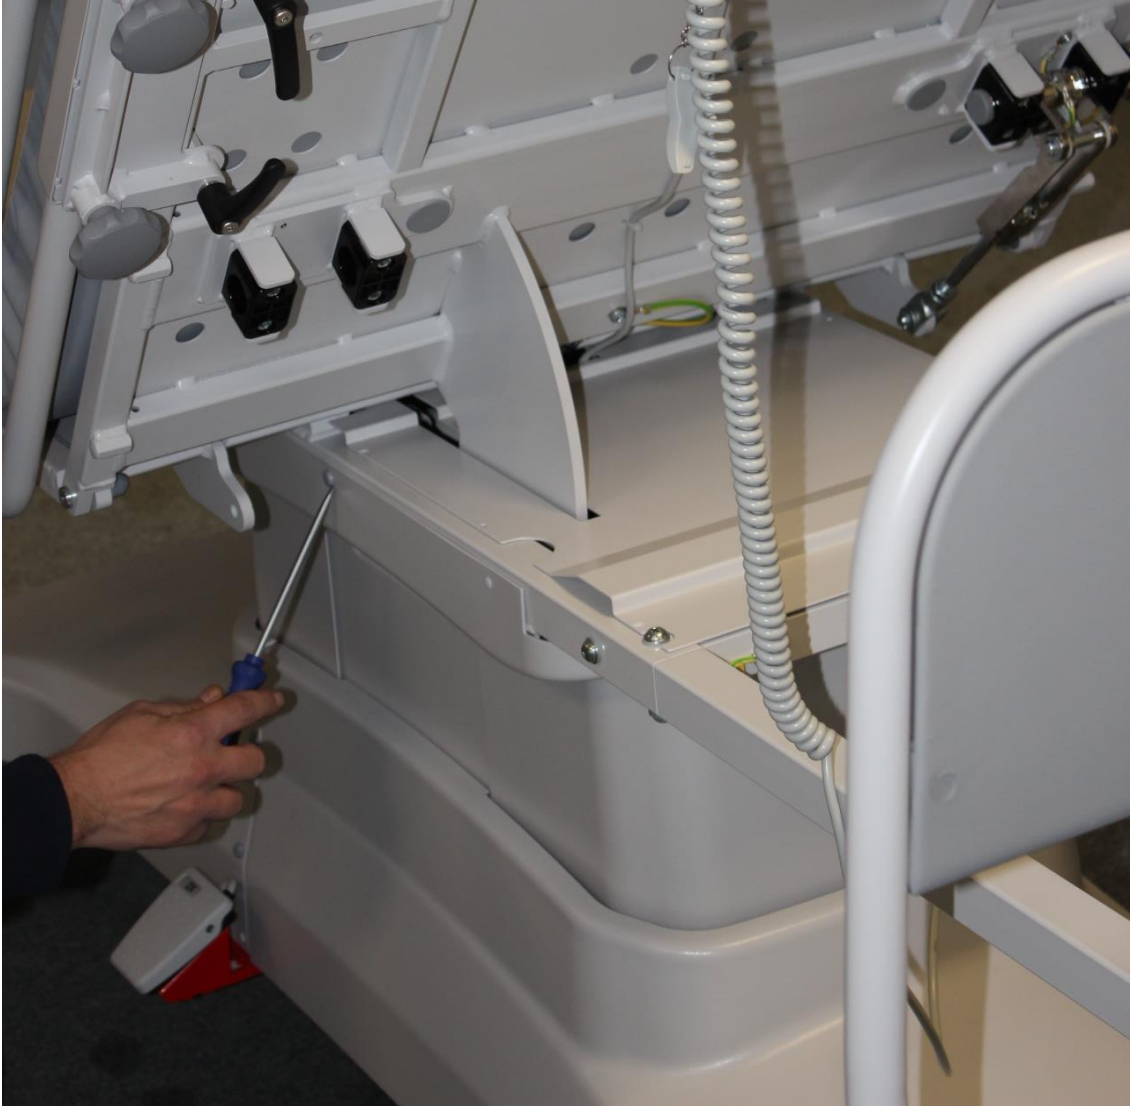
1. Remove the cover cap on the side panel

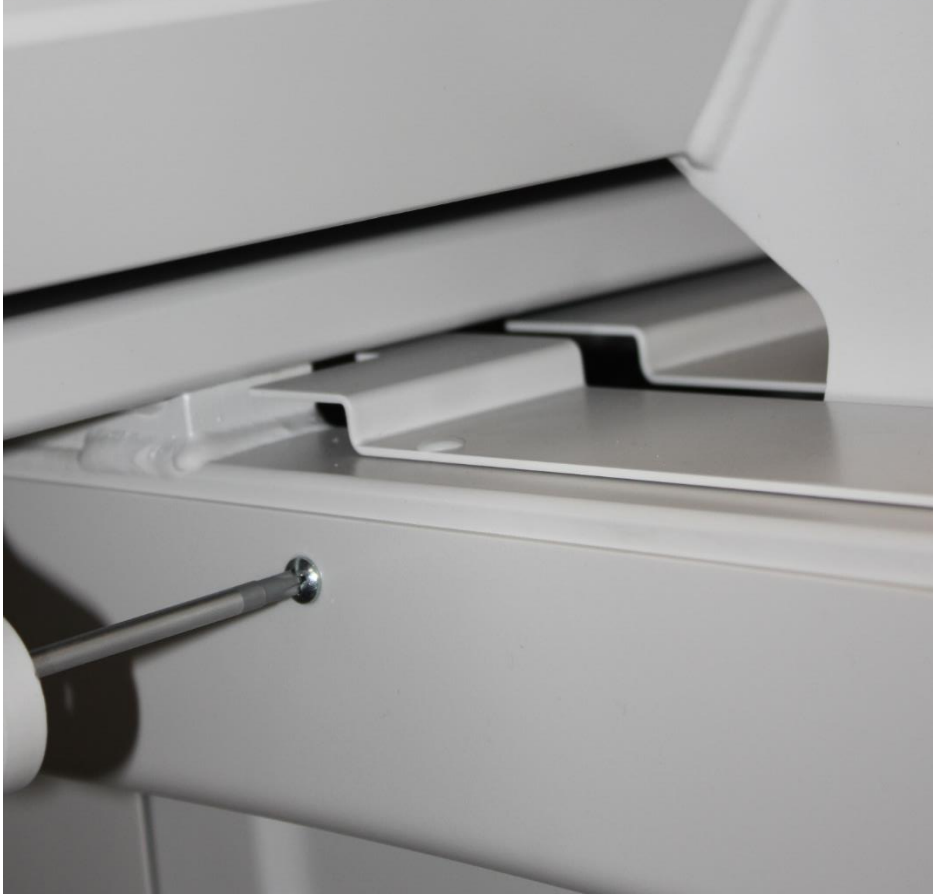
2. Unscrew screw

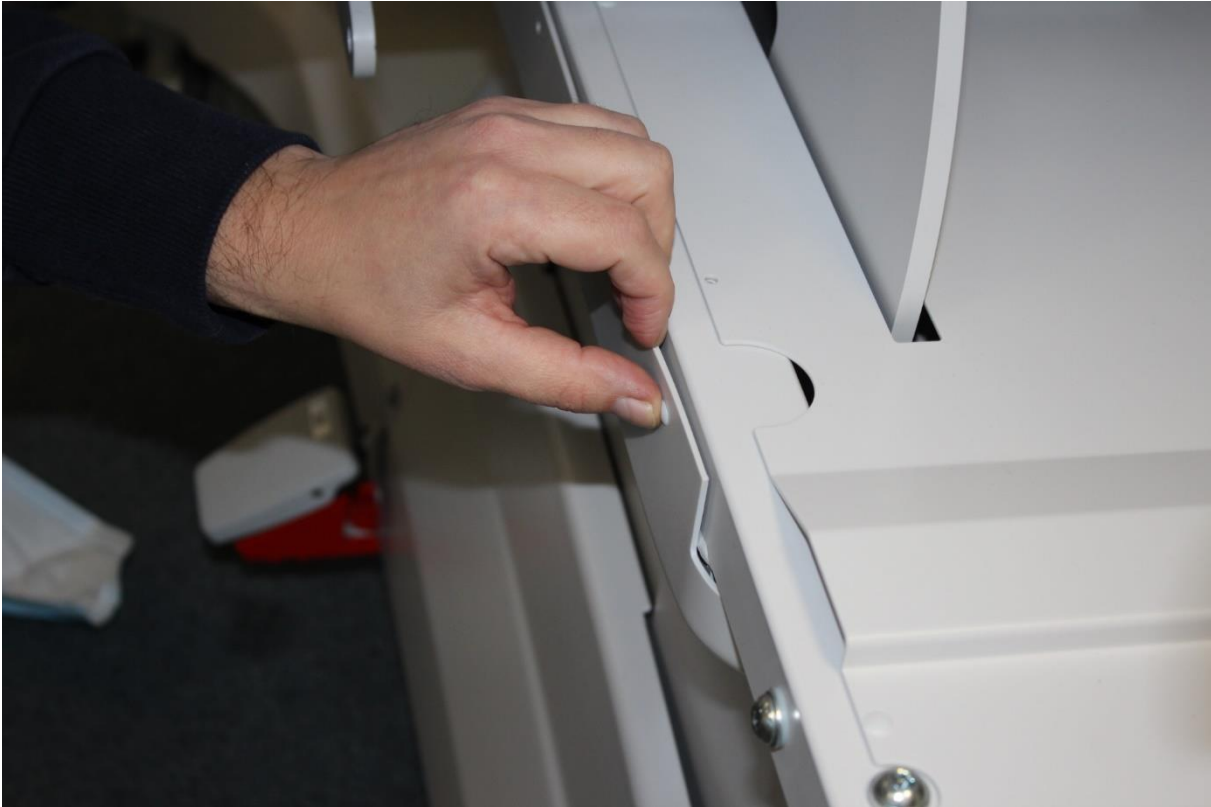
3. Release the two snap fasteners that hold the panel by pulling gently.

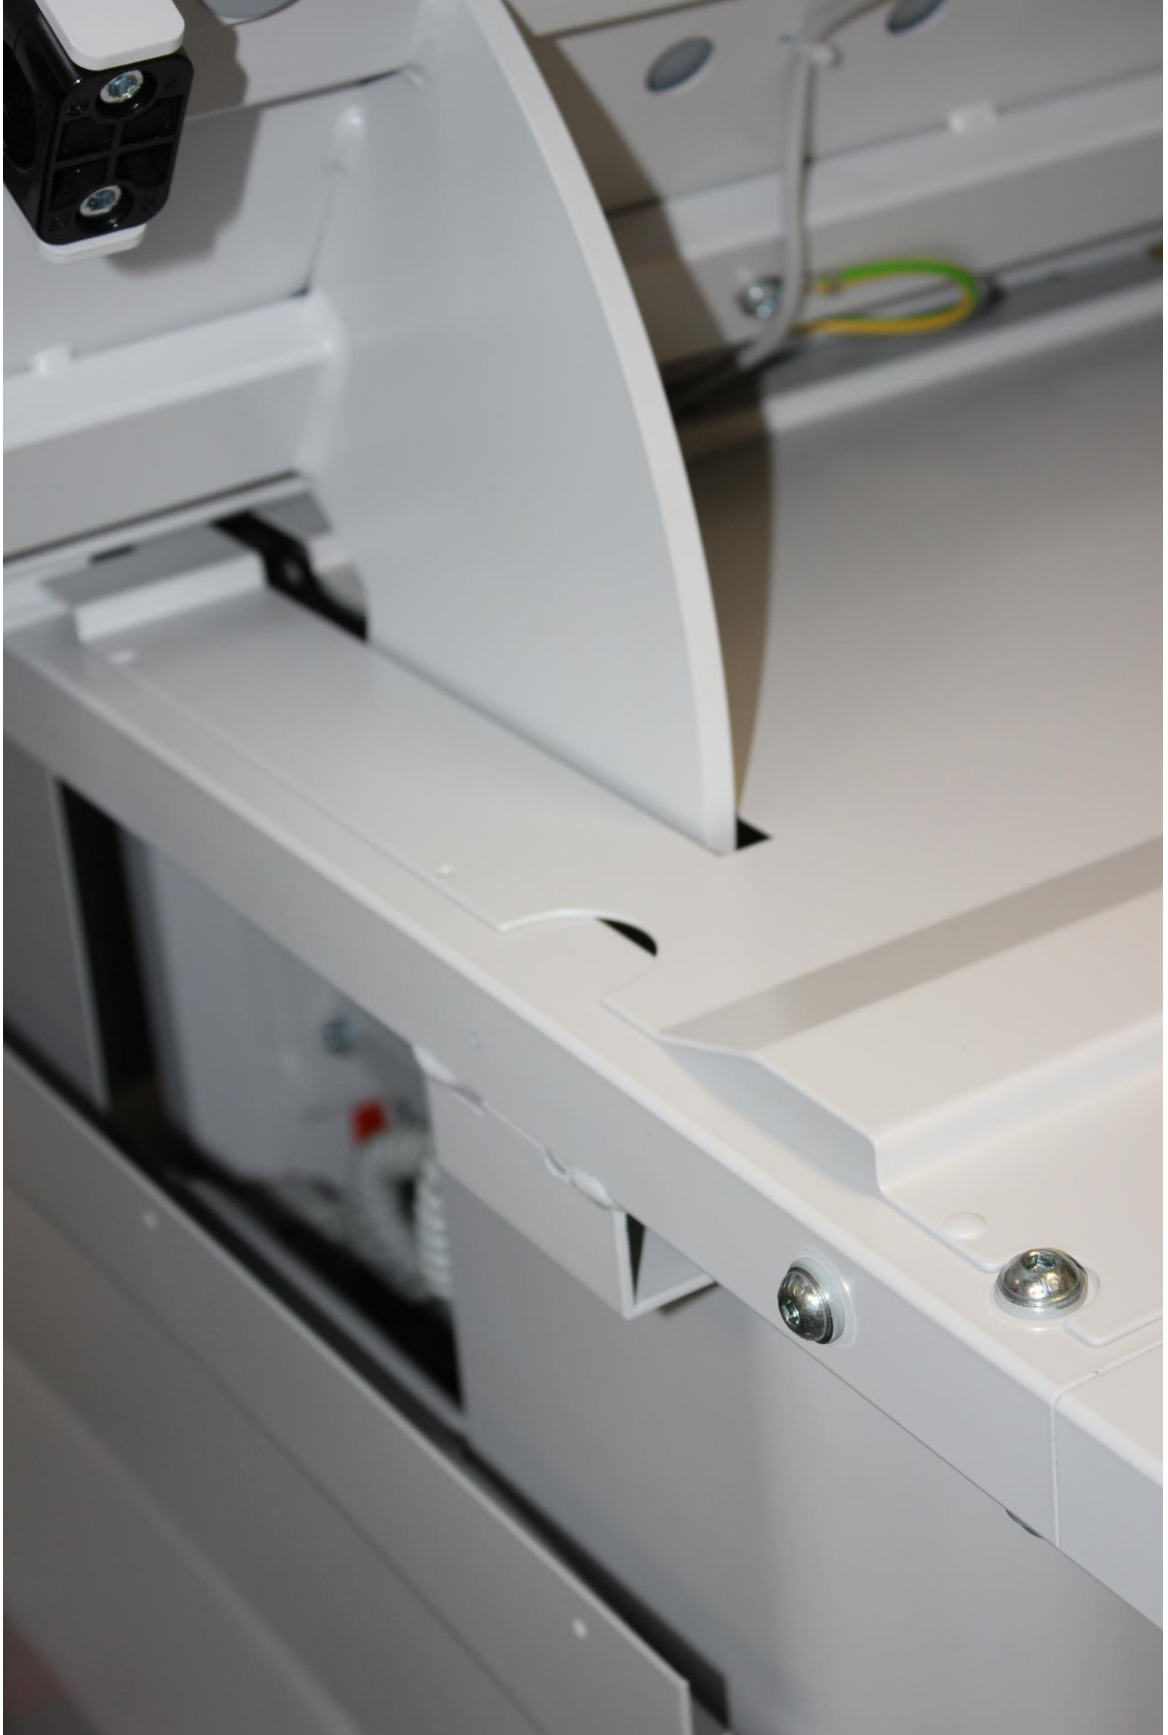
4. Lower the side panel.

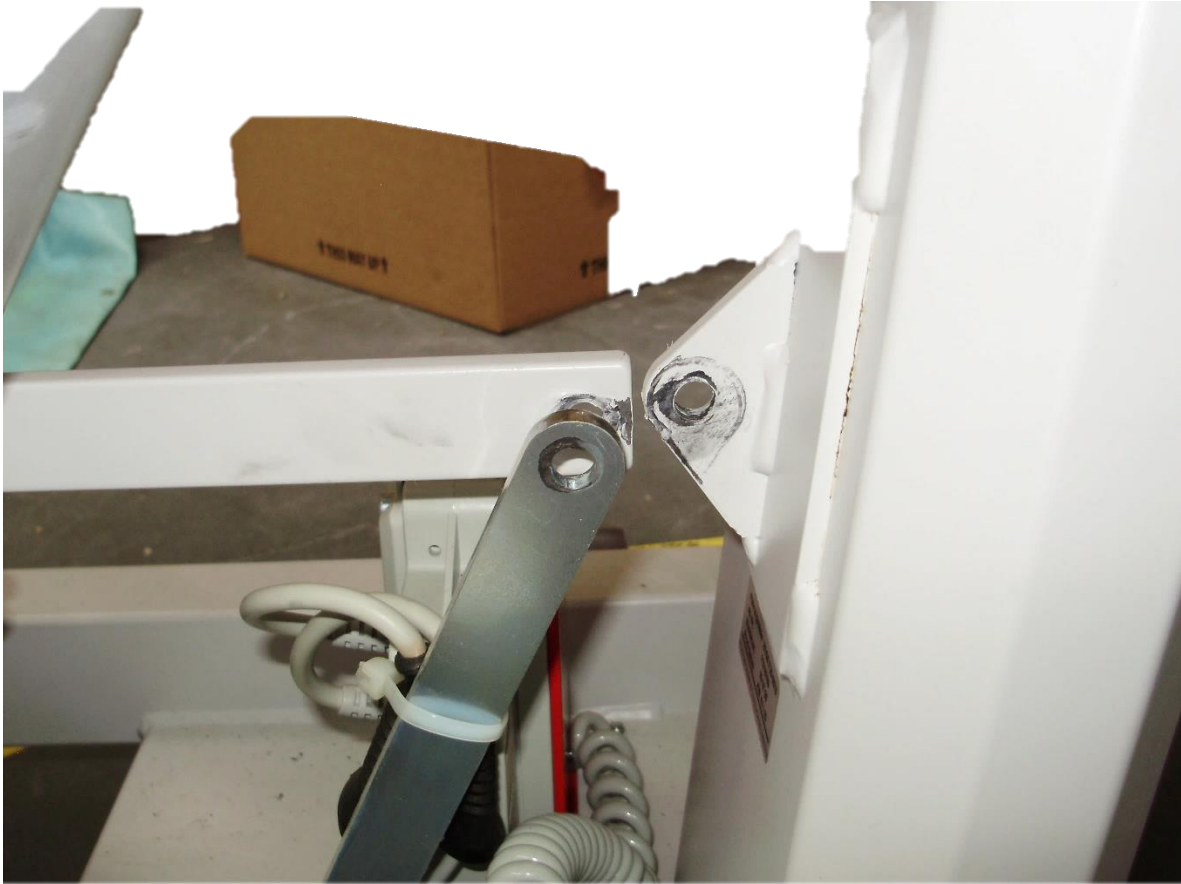
Prior to 2019, a too weak screw was used in the production of the SELEXA bed chair, and this could have been damaged prematurely by overtightening of the screw. This can cause the SELEXA to tilt forwards. There have been two complaints where a screw broke and caused the SELEXA to tilt forwards.

5. Check Screws, that these are not damaged
Broken screw (not okay)

LiKAMED will immediately provide every dealer with a retrofit kit. This retrofit kit consists of a permanent retrofit kit and a temporary retrofit kit. LiKAMED recommends retrofitting the affected SELEXA bed chair with the permanent retrofit kit (working time approx. 45 minutes) at the next routine maintenance. If the next maintenance is not scheduled within the next 90 days, you should secure the affected SELEXA with the temporary retrofit kit (working time approx. 5 minutes). We thank you for your understanding for this retrofit.

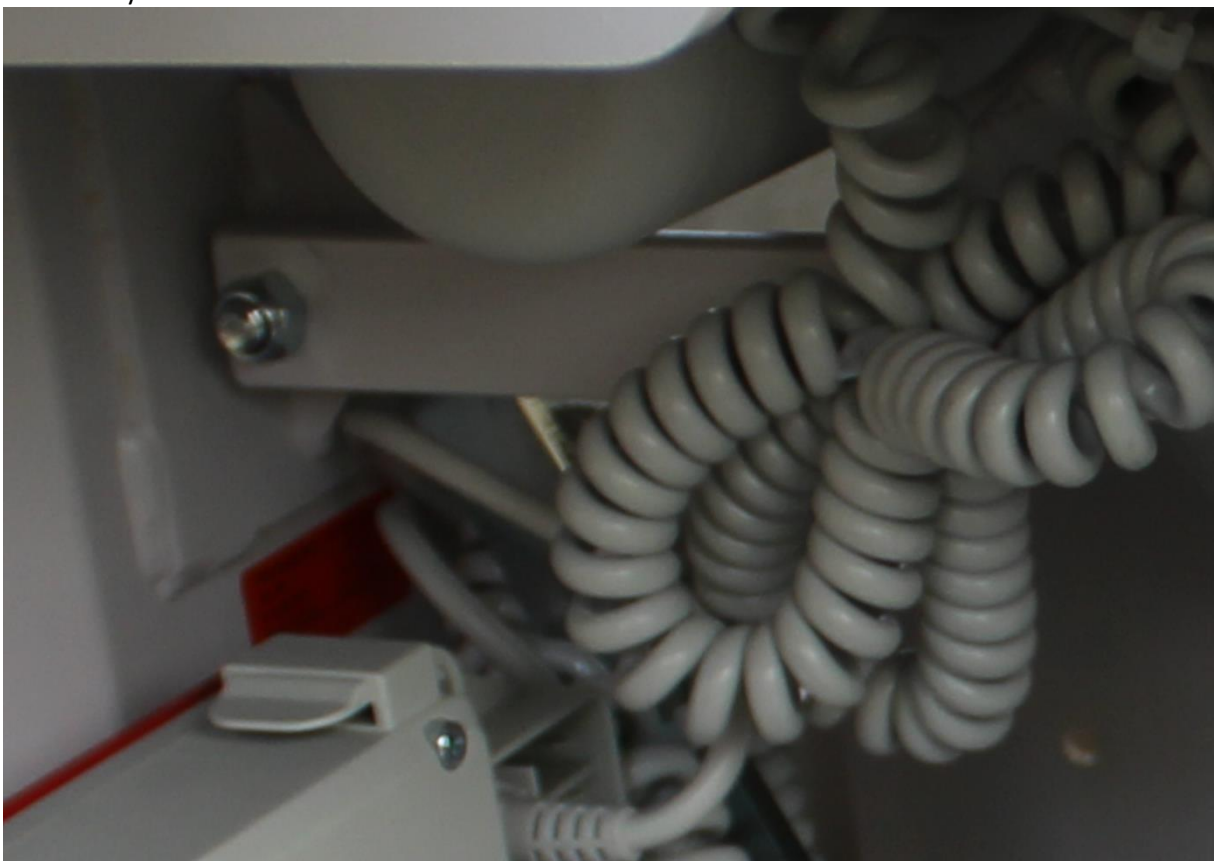
Screw okay
