Field Safety Notice

Height Adjustable (HA) FlexTrak Trolley
 Potential falling hazard resulting from HA FlexTrak Trolley oil leakage

03-May-2024

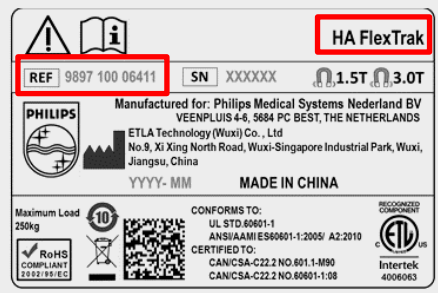
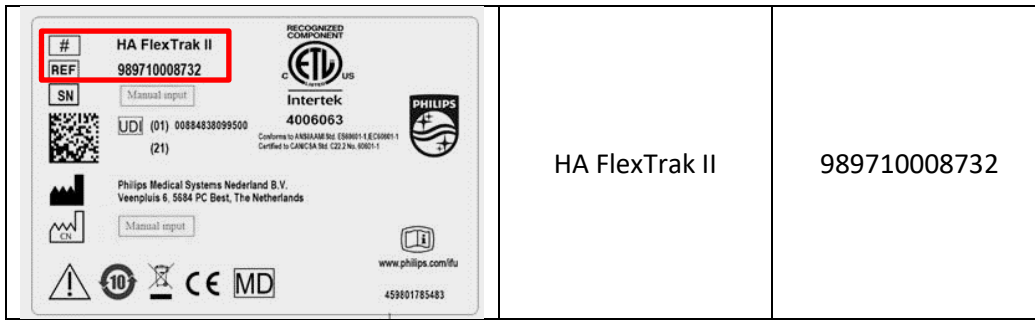
Impacted products can be identified by the product name and product number (REF) as shown in Figure 1.

Example Product Label	Product Name	Product Number (REF)

HA FlexTrak	989710006411
		989710006412

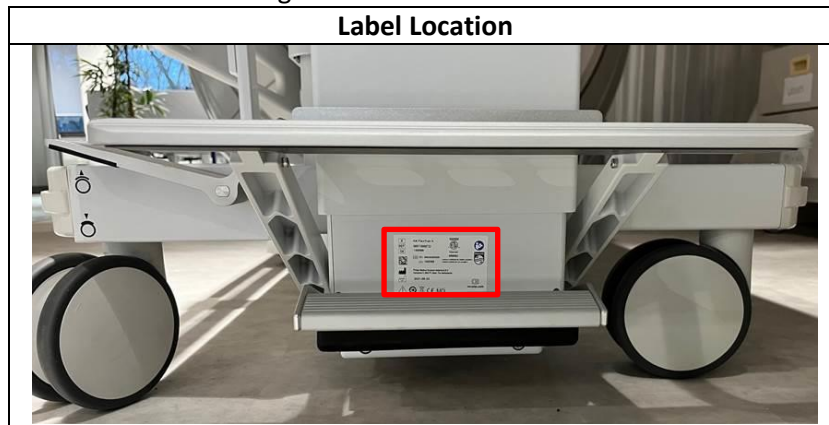
Figure 2. HA FlexTrak Label Location

The HA FlexTrak identification label is positioned on the handgrip side of the trolley below the pump pedal, as shown in Figure 2.
