FSCA Ref: 001.01.2023

Date: 2023.01.22; update: 2023.02.13; update: 2023.02.23

Field Safety Notice
Belzer UW® Cold Storage Solution; Belzer MPS® & StoreProtect®

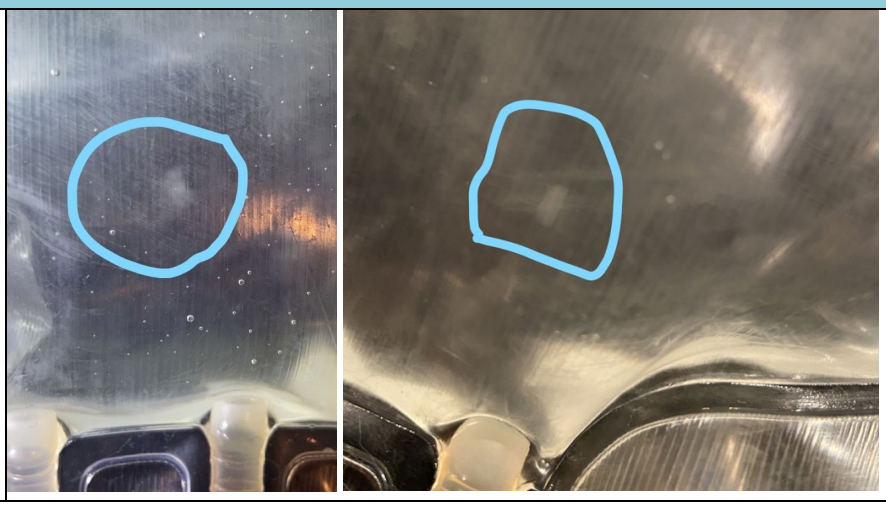
- leaking within the solution bag overwrap,
- turbidity and discoloration;
- visible particulates.

Leakages and turbidity/ discoloration occur when the sterile barrier of the product is lost. Several factors can cause these defects: the EVA bag micro-sealing issue, the EVA bag injection port issue, the aseptic process issue. These issues affect only the individual affected bags, not the entire batch (LOT). The original issue is related to the individual EVA bags and can contribute to the aseptic process and result in microbiological contamination.

The presence of visible particles in the solution is the result of overheating caused by failure to meet the manufacturer's specified transport/ storage temperature in the supply chain.

CONTAMINATED BAG	
LEAKAGE	
Description: Picture of Leaking Bag	  
TURBICIDY/ DISCOLORATION	
Description: Picture of the turbid/ discolored solution

PARTICLES	
Description: Particulate Matter in Solution

5. **Conduct** a physical count and **record** the data on the Customer Reply Form (in case of the hospitals/ clinics/ etc.) attached to the FSN.
6. **Perform** and additional visual inspections according to this Appendix to identify bags of solution that may represent leaking, discoloration, and contamination with particles prior to use of product.
   Should you have any existing product from the lots above or identify any units of solution containing leakage, discoloration or signs of contamination take immediate action to quarantine and report this information.
   Only fluid presenting a colourless appearance should be considered uncontaminated. Before any use of the product, check their condition according to the IFU (Instructions for Use), section **PREPARATION**.

7. **Dispose** of the affected products through waste system, recycle packaging and **document** that on the Customer Reply Form attached to this Notice. If there is no possibility to dispose of the product in this way, you may return the product to local Customer representative through your normal means.
8. **Return** the Customer Reply Form to:
   - your local representative/ distributor (in country BTL representative: f.harvey@b2ll.com and m.harper@b2ll.com);
   - or via e-mail to vigilance@carnamedica.com.
