Important Medical Device Information

Cardiac Rhythm Management

September 2014

Summary

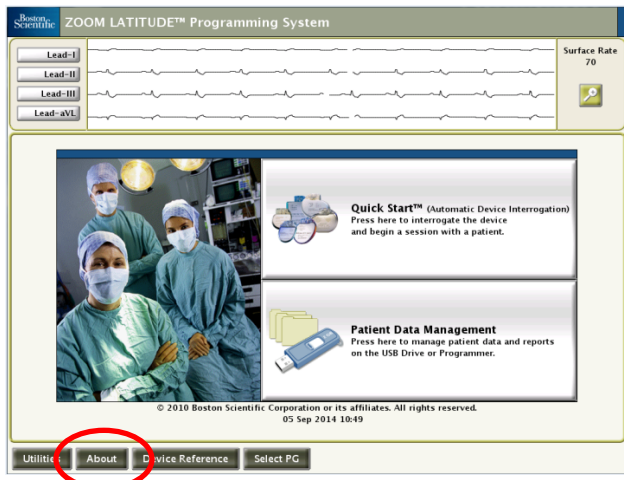
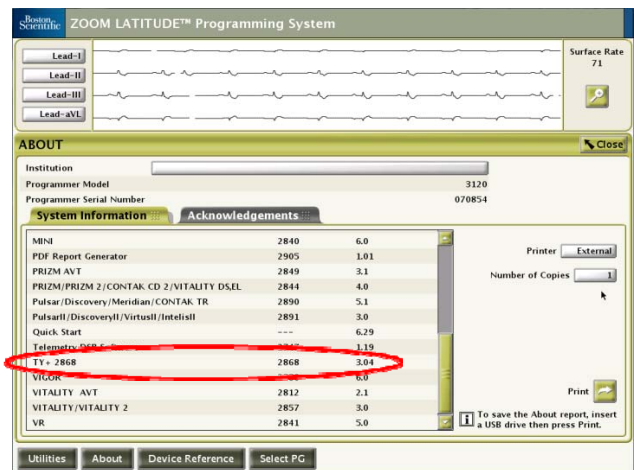
How can I tell if a Model 3120 Programmer has been updated with the new version of software?

- Look for Model 2868, version 3.04 under System Information on the About screen
