**Subject: Pacemakers – Technical programming information on Minute Ventilation Sensor.**

Ref.: 92186345-FA

Product name	Models
VALITUDE™ CRT-P	U125, U128
ACCOLADE™ Pacemakers	L300, L301, L310, L311, L321, L331
ESSENTIO™ Pacemakers	L100, L101, L110, L111, L121, L131
VISIONIST™ CRT-P	U225, U226, U228
PROPONENT™ Pacemakers	L200, L201, L209, L210, L211, L221, L231
ALTRUA™ 2 Pacemakers	S701, S702, S722

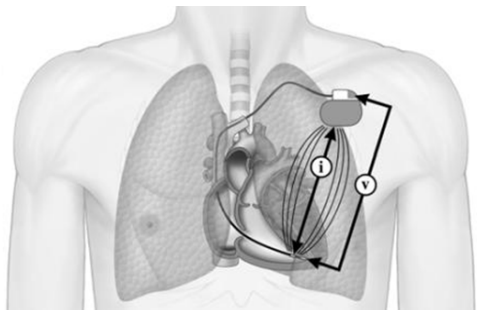
Figure 1. Measurement of the MV Signal from the RV lead

Boston Scientific pacemakers use transthoracic impedance to measure MV which is a product of respiration rate and tidal volume. During inhalation, the increased volume of air in the chest cavity produces an increase in transthoracic impedance. Likewise, during exhalation, the decreased volume of air produces a decrease in transthoracic impedance. Transthoracic impedance measurements are obtained through delivering a subthreshold current waveform approximately every 50 ms between the lead ring electrode and the pacemaker case, and measuring the resultant voltage between the lead tip and the pacemaker case (Figure 1). Boston Scientific pacemakers use the MV sensor for RightRate™ (rate adaptive pacing), Respiratory Rate Trend, and AP Scan™<sup>6</sup>.

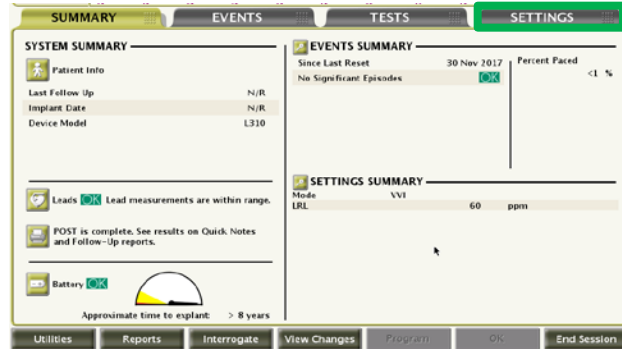
1. On the Summary page, select

"Settings" Tab

For all affected pacemakers and affected CRT-Ps, turn the MV Sensor "OFF" by disabling it within the Rate Adaptive Pacing settings

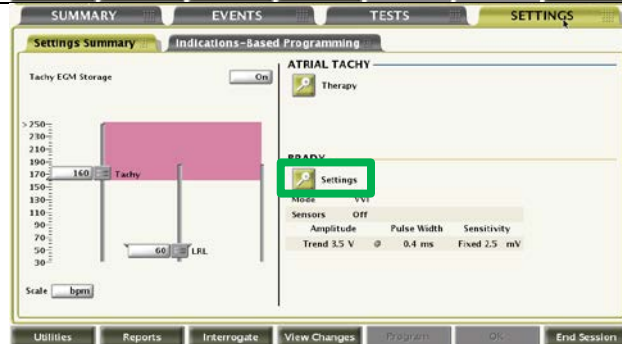
2. On Settings Summary Tab, in the Brady section select

"Settings" button

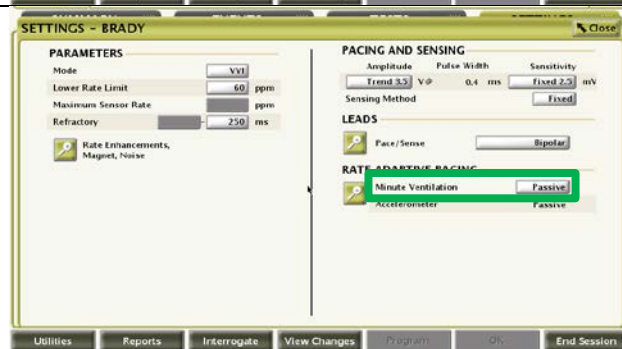
3. On Settings – Brady page, in the Rate Adaptive Pacing section, review the Minute Ventilation programmed value.

If the value is "Passive" or "ON" the MV sensor is enabled.

4. To eliminate the potential for oversensing the MV sensor signal, program the Minute Ventilation Sensor to "OFF"

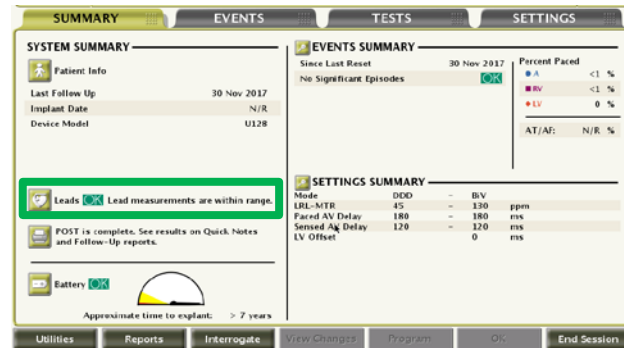
1. On the Summary page, select

“Leads” Button

For US configurations of affected CRT-PS, turn the MV Sensor “OFF” by disabling Respiratory Rate Trend.

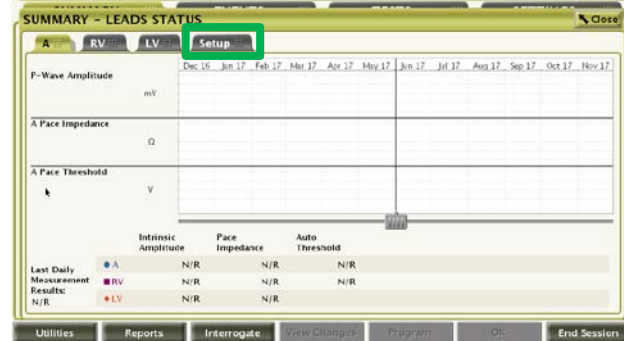
2. On the Summary – Leads Status page, select

“Setup” Tab

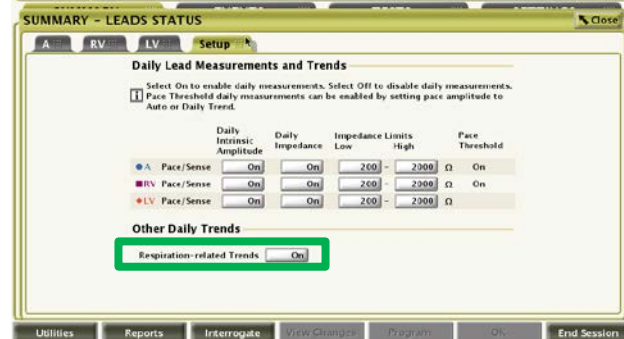
3. On the Summary – Leads Status page, in the Other Daily Trends section, review the Respiration-related Trends value.

If the value is “ON” the MV sensor is enabled.

4. To eliminate the potential for oversensing the MV sensor signal, program the Respiration-related Trends value to “OFF”
