Urgent Field Safety Notice

**Ambu AuraGain
December 11, 2015**

Ambu® AuraGain™ - Single Use Laryngeal Mask - Sterile

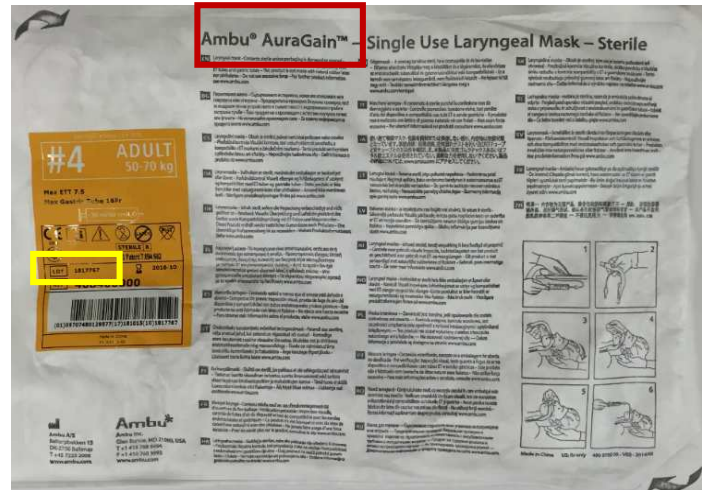
Please see picture to the right for positive identification of the device:

Note identification of device name highlighted with red box, and identification of LOT number highlighted with yellow box

Follow these instructions to identify the AuraGain devices that may have a broken sterile barrier.
