URGENT IMPORTANT FIELD SAFETY NOTIFICATION

Subject: Potential incorrect positioning after verification scan

Product: iGUIDE® Software 2.2

Scope: iGUIDE® 2.2.0, iGUIDE® 2.2.1

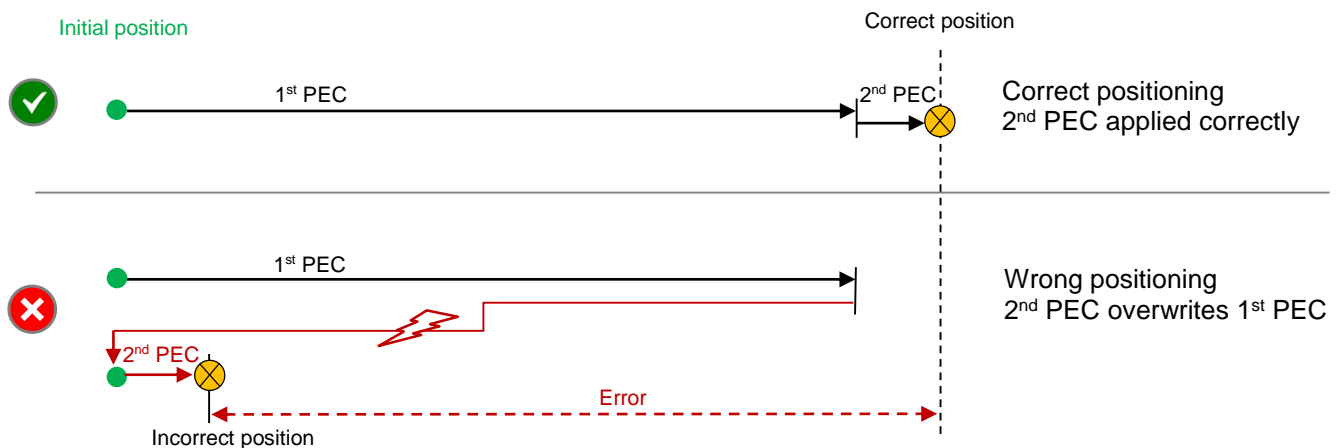
If the PEC data dialog after a verification scan is cancelled, a re-send of PEC data will lead to incorrect positioning because the 2nd PEC values supersede the 1st PEC values instead of being added.

1. In the iGUIDE 6D correction workflow, the 1st XVI scan is executed and the 1st PEC is performed correctly, i.e. the HexaPOD is moved to the specified position.
2. The verification scan is performed on XVI and the 2nd PEC is sent to iGUIDE. The PEC data dialog is cancelled by the user. This cancellation is the trigger for the following incorrect positioning.
3. The user decides to apply the 2nd PEC data and re-sends the values from XVI to iGUIDE. The iGUIDE software does not recognize this data as an additional PEC (to be added) but overwrites the first PEC instead. This wrong behavior of the software leads to a wrong positioning in the order of magnitude of the first PEC.

Do not cancel the 2nd iGUIDE PEC data dialog (and confirm the cancellation) for a verification scan. If you have cancelled the 2nd PEC data dialog, you have to restart the positioning and return to the beginning of

the positioning procedure. To do that, click the
