FIELD SAFETY NOTICE

Date: 2010-02-02
Author: Trina Turcotte, tturcotte@bhm-medical.com
Subject: FSN01/2010/ca.EN
Product group: Floor Lifts
Document number: FSN01/2010/ca.EN
Issue: 1
Case No: NA

SINGLE INSULATION POWER CABLE

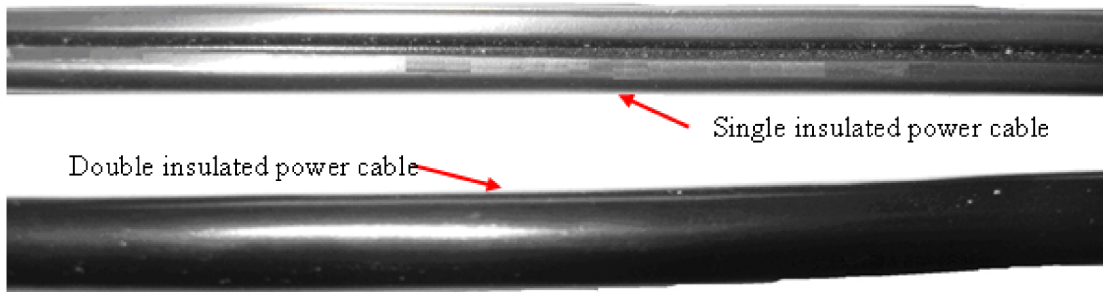
During the assembly of some of the above mentioned products, an improper power cable was installed on the control box. This power cable is single insulated, which increases the risk of premature failure.

Fig 1: Power cable location

A power cable failure could result in a connection between the metal structure of the hoist and the main power. Therefore, there is a risk of electrical shock for the user while the hoist is plugged to an electrical outlet.

The single insulated power cable will be replaced, free of charge, by our dealers/distributors.
