## **FIELD SAFETY CORRECTIVE ACTION**

**DATE:** 21<sup>st</sup> June 2016

**SUBJECT:** TAPERLOC HIP LATERALISED PC STEM 15.0mm 12/14 Taper

**SUBJECT:** TAPERLOC HIP LATERALISED PC STEM 17.5mm 12/14 Taper

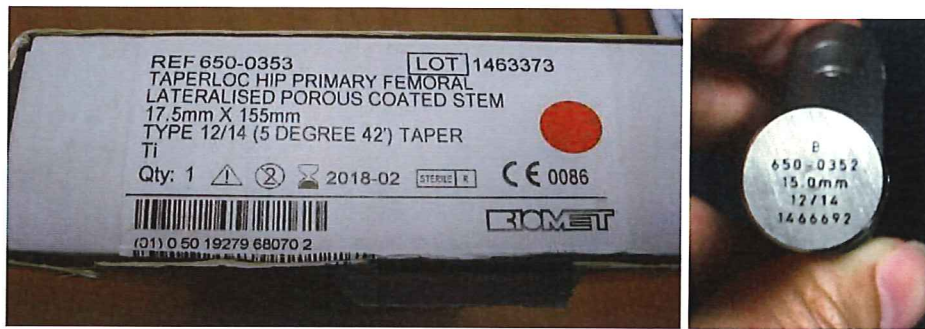
Biomet UK Ltd has initiated this action following an investigation that found that the packaging for a TAPERLOC LAT PC 17.5mm 12/14 stem, product code 650-0353, lot 1463373, contained an item with the product code 650-0352, lot 1466692 which is a TAPERLOC LAT PC 15.0mm 12/14.

The hip stem's lot number and size are etched on the top of the stem taper trunion, which would be checked by the theatre staff on opening the box and reviewing the component. This would identify a mismatch between label and product identification. An example can be seen in the pictures over the page.

**If the condition was not identified upon opening the box and if the surgeon had planned for a 17.5mm stem but used a 15mm stem, the stem would be undersized and sit obviously lower in the prepared femur. It is likely that the surgeon would identify the mismatch in size, because the smaller hip stem implanted would not achieve sufficient press-fit and would likely move.**

**If the surgeon had planned for a 15mm stem but used a 17.5mm stem, given the wedge shaped design of the stem, it would sit obviously proud of the resection level in the prepared femur.**

1. To assist us with this action, please ensure that the operating staff are made aware of this matter without delay and that all the affected products identified are withdrawn from use at your facility as soon as possible.
